UNDERGROUND NEWS

FEBRUARY 1987

THE
KENSAL GREEN
COLLISION

THE KENSAL GREEN COLLISION ENQUIRY

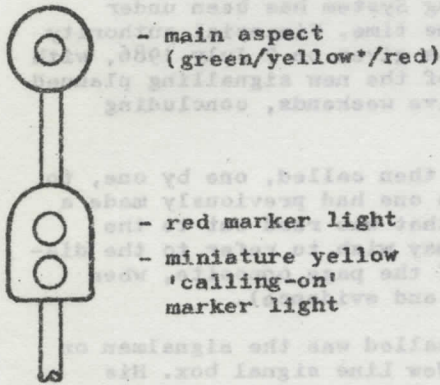
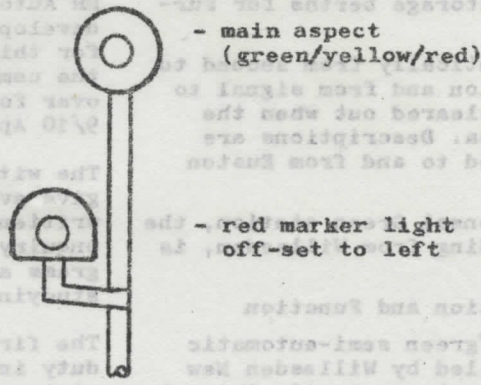
Figure 1: CAMDEN-WATFORD 'NEW LINE' SIGNALLING SYSTEM

The installation comprises two and three aspect searchlight type signals, with associated marker lights and train stops. The signals are of two basic types, stop signals and repeater signals. The stop signals are equipped with an associated train stop, with marker lights arranged vertically beneath the main aspect. Repeater signals do not generally have an associated train stop and the marker light is off-set to the left. (See Fig.1). Stop signals are identified by a number consisting of two alpha characters and a digit. Repeater signals are similarly identified but with a prefix 'R' on the signal number.

The signals are, in the main, sub-divided into two types, these being semi-automatic and fully automatic signals. These signals are distinguished by identification plates with the semi-automatic carrying a diamond sign with superimposed 'T' and the automatic signal carrying a

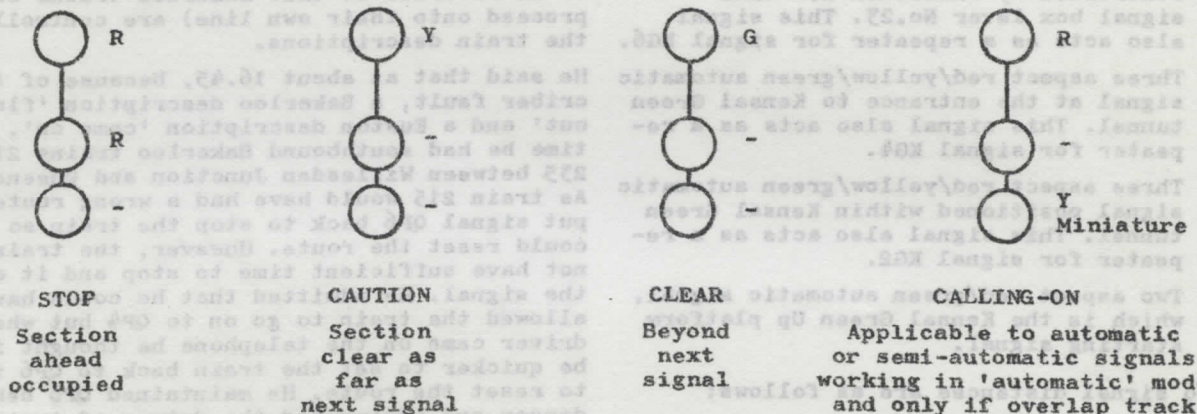
Figure 2: OPERATION OF STOP SIGNAL ASPECTS

The normal aspect exhibited at an automatic and semi-automatic signal when working automatically is clear. After the leading wheels of a train pass such a signal, the aspect changes to danger and the signal is held in this position until the rear of the train passes a point beyond the next stop signal in advance. Repeater signals will normally exhibit a caution aspect when the next signal in advance is at danger and a clear aspect when this signal is displaying a clear or caution aspect. Should the line be occupied between a repeater signal and a point beyond the next signal in advance, a danger aspect will be displayed. The marker lights display a red aspect when the main aspect is also red and are extinguished when the main aspect displays a proceed aspect. If a main danger aspect continues to be displayed on an automatic or semi-automatic signal when working automatically, the red marker light will change to a yellow

calling-on aspect after the berth track circuit for the signal concerned has been occupied for a time. The time is so set as to normally require a train to be at a stand at the signal concerned for about 60 seconds before the presentation of the calling-on aspect. Drivers are instructed not to proceed on a calling-on aspect until the train has been at a stand at the signal for one minute. (See Fig.2).

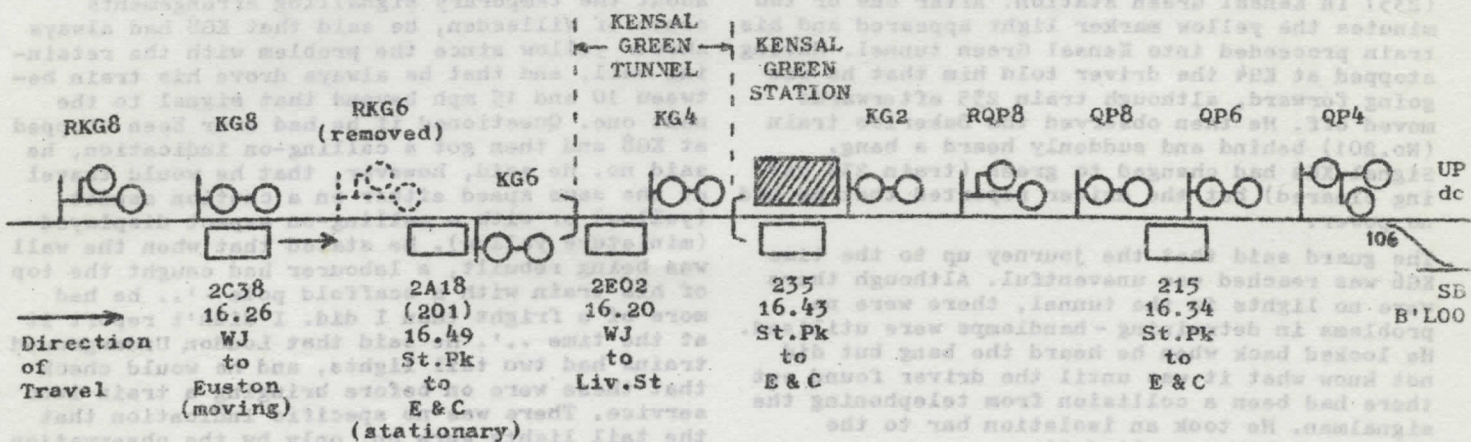
Figure 3: POSITION OF TRAINS LEADING UP TO THE COLLISION

He said that at about 16.45, because of the describer fault, a Bakerloo description 'flashed out' and a Euston description 'came on'. At the time he had southbound Bakerloo trains 215 and 235 between Willesden Junction and Queens Park. As train 215 would have had a wrong route, he put signal QP6 back to stop the train so he could reset the route. However, the train did not have sufficient time to stop and it overran the signal. He admitted that he could have allowed the train to go on to QP4 but when the driver came on the telephone he thought it would be quicker to set the train back to QP6 in order to reset the route. He maintained QP8 behind at danger and instructed the driver of train 215 to set back, after cautioning the driver of the following train (235) not to leave Kensal Green. The manoeuvre took longer than he expected and a queue of trains built up behind train 215.

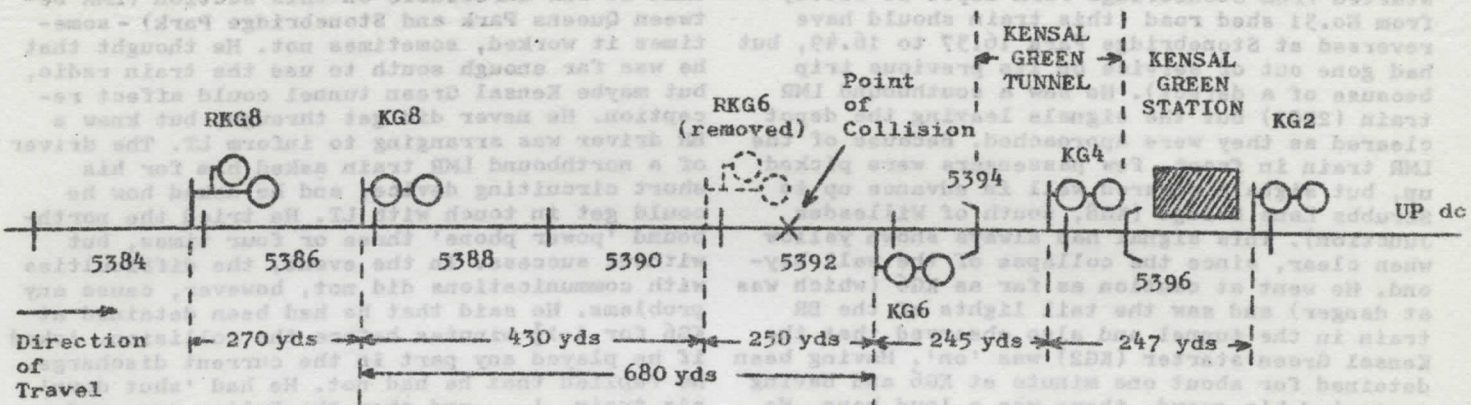
Figure 4: SIGNALS AND TRACK CIRCUITS IN COLLISION AREA

RKG8 to KG8 - 270 yards
KG8 to KG6 - 680 yards
KG6 to KG4 - 245 yards
KG4 to KG2 - 247 yards

In late-1985 a retaining wall situated on the Up side of the dc line between signals KG8 and KG6 became unstable and necessitated extensive repairs. During the course of this repair work it became apparent that the repeater signal for KG6 (numbered RKG6) would be obscured by scaffolding and sheets associated with the repair work. To permit the urgent repairs to continue, arrangements were made for signal RKG6 to be removed. Due to the removal of the repeater signal, the short term expedient of controlling signal KG8 to maximum yellow was adopted. This solution preserved the green,yellow, red sequence when KG6 was displaying a danger aspect and minimised the amount of modifications to signalling controls necessary at a time when the cable and lineside plant was being severely disrupted due to the wall reconstruction works. Subsequent works on the retaining wall completely obliterated the site and the structure of signal RKG6, necessitating a complete renewal.
