‘STOP AND PROCEED’ COLLISIONS

by David Millard

The purpose of this article is to look at ‘stop and proceed’ collisions. ‘Stop and proceed’ was needed to keep the service moving in the event of an automatic signal failure, and required ‘line of sight’ driving. Common factors associated with these collisions are identified and considered in the context of the overall safety performance of the trainstop and tripcock signalling system.

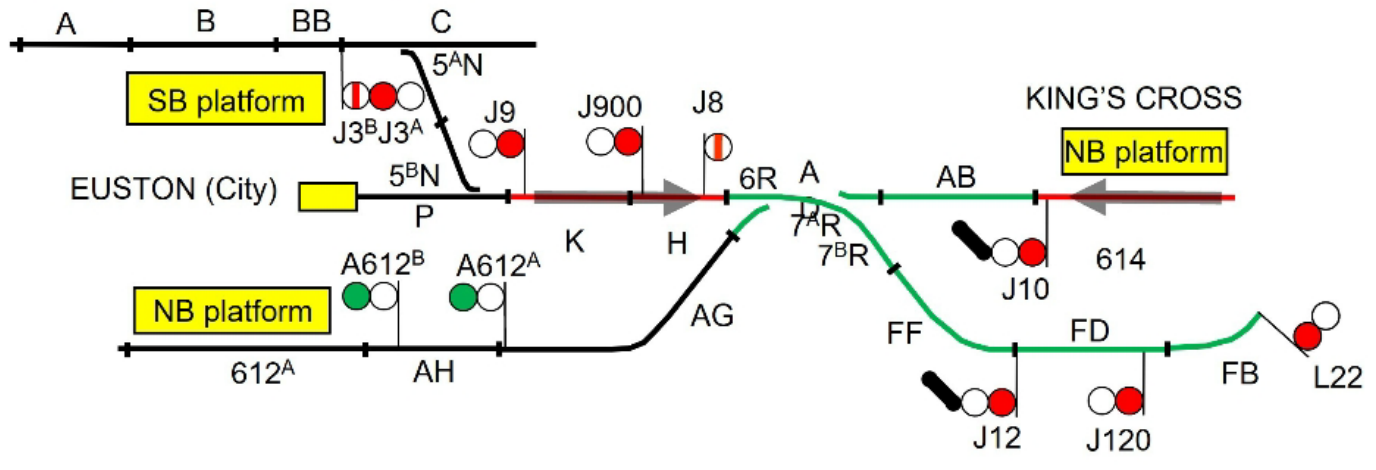
Kings Cross (Northern) to Euston City, 17 Feb 1997

At the end of a disrupted morning peak, an empty train was in Euston Loop, waiting to be routed to King's Cross Loop to reverse south to north bound. A train then arrived in King's Cross northbound platform. In the absence of the route being set across the train, clearance of signal J10 required occupation of the platform track for 15 seconds, so this signal was always at danger when the train arrived, and normally cleared within a few seconds of the train coming to rest. The platform repeater was on the headwall; on the morning in question, the bulb for the yellow aspect did not work. The guard closed the doors and gave the driver the starting bell. The driver started the train and was tripped. He called the guard on the train telephone and asked whether the signal had cleared. The guard said that he did not know. The driver reset his trip, restored air, released his brakes and set off at close to normal speed. When traversing 7^A points, which were set against him, the leading truck derailed, throwing him off his seat. The train came to rest on the concrete some 2½ cars (41 metres) beyond the point of derailment. Some test runs were arranged for a subsequent night which indicated a speed at the point of derailment of 22 mph. Had the train split the points and remained on the rails, it would have encountered the train in Euston Loop at some speed. The driver clearly had it firmly in his mind that the road ahead was clear, despite the starting signal (directly in front of him) remaining red, and being tripped when passing the signal. This incident did not result in a Railway Inspectorate inquiry, perhaps because no one suffered more than shock. In general, there were a fair number of signals passed at danger incidents where the driver continued without authority, although most were at low speed.

Selected signalling elements shown

Clearance of signal J8 requires permission from the train regulator for the Kings Cross desk of the Piccadilly line – when this is given, a route cannot be set into Kings Cross loop in the opposite direction
