LOCOMOTIVE L11 & EPPING SIGNAL CABIN

by Bob Yeldham – Head of Projects – Epping

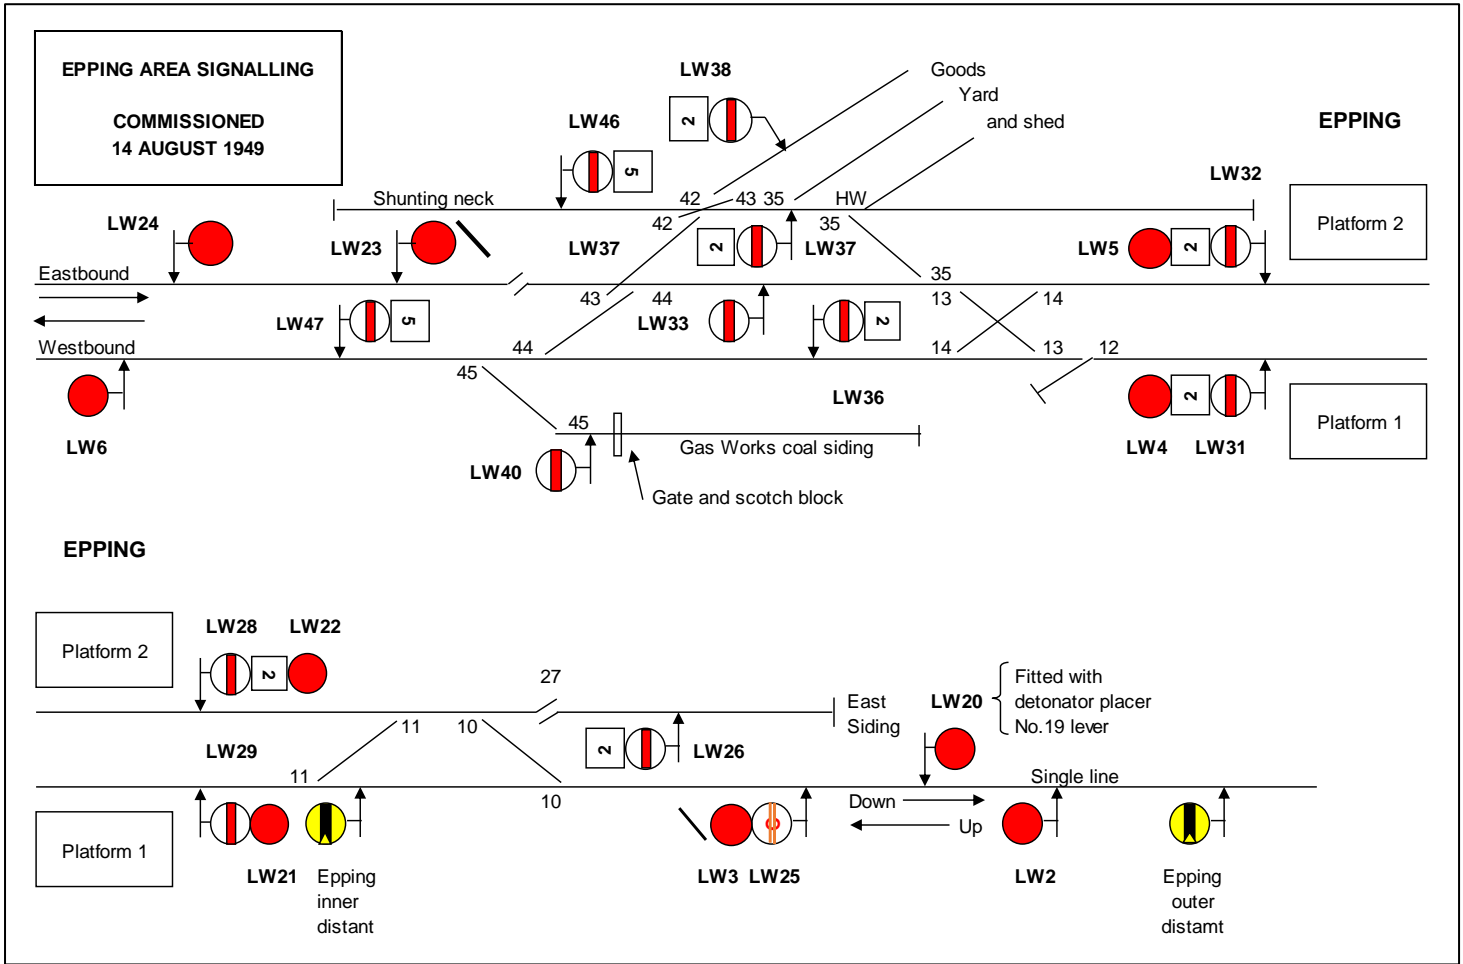
Above: Diagram of signalling at Epping from the time it was opened in August 1949, showing the connections to the goods yard and sidings on the eastbound side and also the gas works siding west of the station on the westbound side

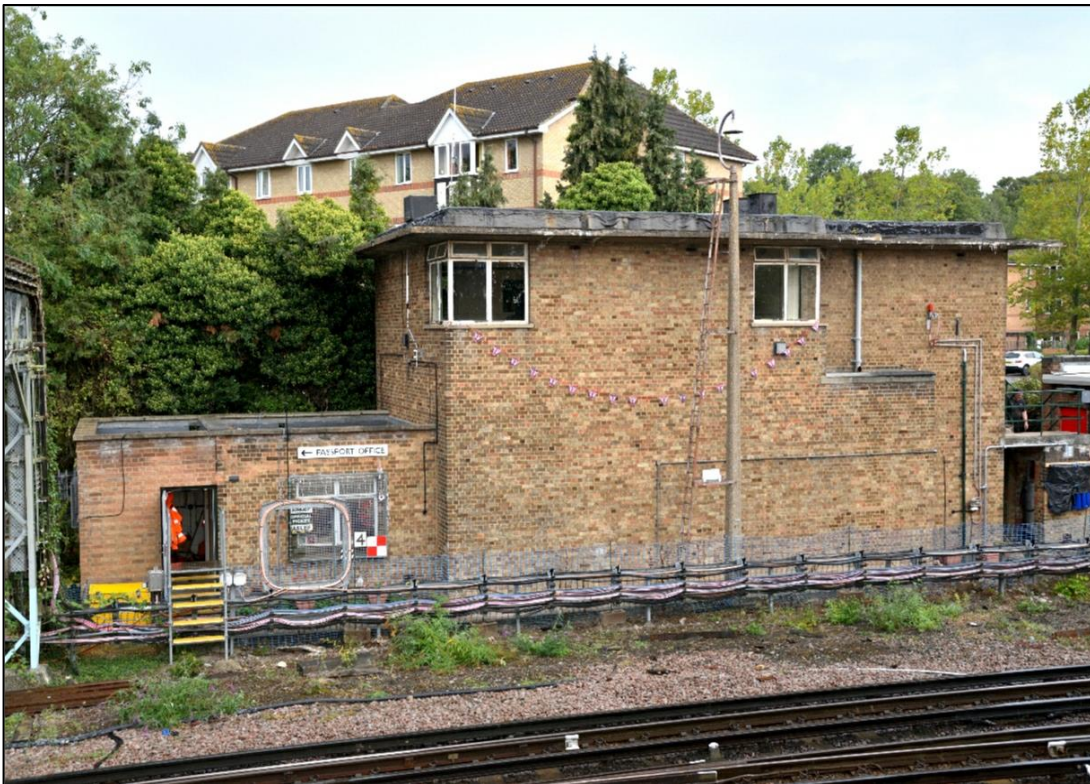
Left: The exterior of Epping signal cabin, which is located on the eastbound approach to the station. It goes without saying that the goods yard became a car park.
