LONDON UNDERGROUND SIGNALLING

A HISTORY

by Piers Connor

30. MOVING ON

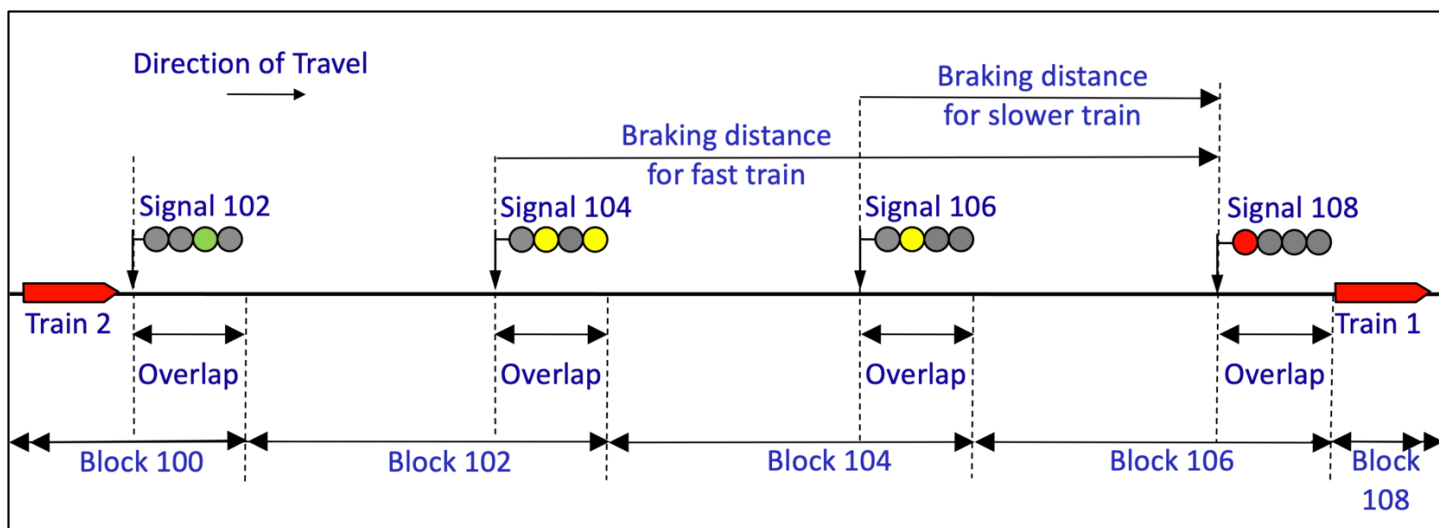
Figure 1: A schematic of a 4-aspect signalling system including overlaps. With Train 1 occupying Block 108, the signal protecting that block (Signal 108) is red, the signal in rear (106) shows a single yellow, indicating one vacant block before the red signal, Signal 104 shows a double yellow, indicating two vacant blocks ahead and Signal 102 indicates at least three blocks ahead are vacant. The double yellow provides the warning of a red signal ahead for fast trains, while the single yellow is sufficient for a slower moving train. Four-aspect signals on the Metropolitan main lines section between Harrow and Watford South Junction were normally spaced at 4,000 feet, or $\frac{3}{4}$ mile. North of Rickmansworth, most of the signals were 3-aspect. Drawing: P. Connor.

The idea for multi-aspect signalling had its origins in the US where, in the 1880s, 3-position upper quadrant semaphore signals began to appear¹. They were adopted by a number of railroads in America and, as I described in Article 16 in this series, in Britain on the Ealing & Shepherd's Bush Railway. The idea was to provide advance warning of block status and it was driven by the desire to increase train speeds and to improve line occupancy without sacrificing safety. In Britain, it was thought by some operators and engineers that three-aspect signals could do this around the country if design principles could be agreed and rules adopted and accepted by operating companies and regulators. In 1922, the Institution of Railway Signal Engineers (IRSE) set up a committee to examine the question and, within two years, they had endorsed the idea and they also suggested that a fourth aspect – the double yellow – should be added where necessary to allow shorter blocks over lines where there were both fast and slower trains were operating. The principles were quickly adopted by the Southern Railway who put in 4-aspect colour lights along their route between Holborn Viaduct and Elephant & Castle in 1926. Since then, both 3-aspect and 4-aspect colour light signalling have become standard systems in Britain. A schematic of the 4-aspect system is in Figure 1 below. I provided a schematic of the 3-aspect system in Article 16.

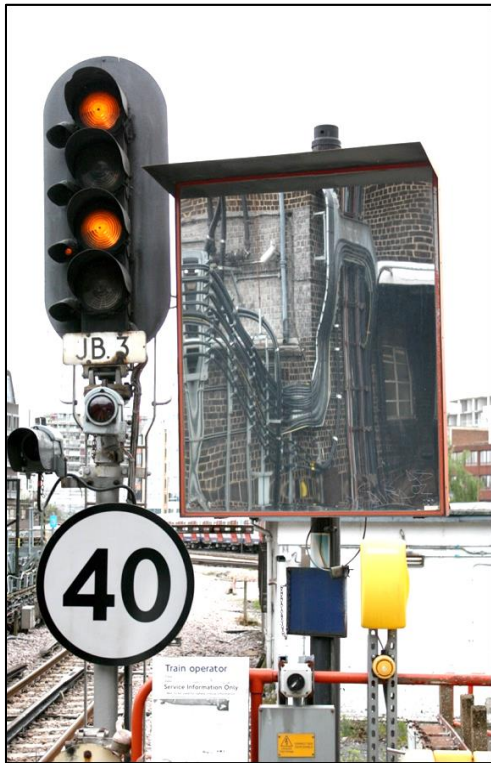
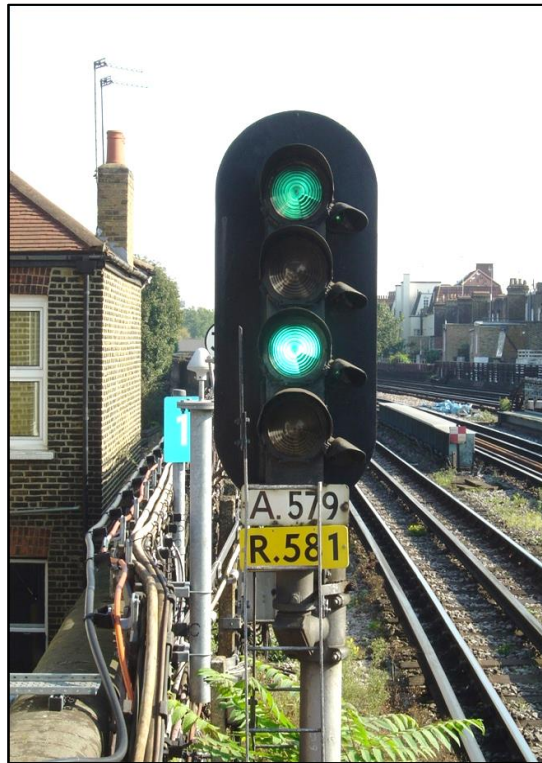
Figure 2: A comparison between a 4-aspect signal and a pair of two aspect signals on the same backplate. On the far left, JB3, the 4-aspect starting signal at Harrow-on-the-Hill Platform 1, shows a double yellow aspect, indicating two block sections ahead are clear. It also has an auxiliary red lamp below the main signal and a tripcock tester light to the left. On the left, two signals on a common backplate, at Stamford Brook (EB), both showing green. The upper green is for the stop signal while the lower one is for the repeater of the next signal. Photos by B. R. Hardy.

With the lack of tripcocks on the main line trains, it was decided that an additional auxiliary aspect, which shows red when illuminated, should be arranged to come on automatically if either the main red (or yellow) aspect failed or the signal main supply was lost. If there was a supply failure, the auxiliary red aspect was fed from an emergency battery supply. Drivers were instructed that any signal at which this auxiliary aspect was illuminated must be treated as being at danger, no matter what the circumstances. This meant that main line drivers were always shown a red aspect at a signal which was at danger, even if the main aspect failed. All the 3- and 4-aspect signals were equipped with these auxiliary aspects. Additionally, if the auxiliary red was illuminated, the signal in rear would show a yellow aspect.

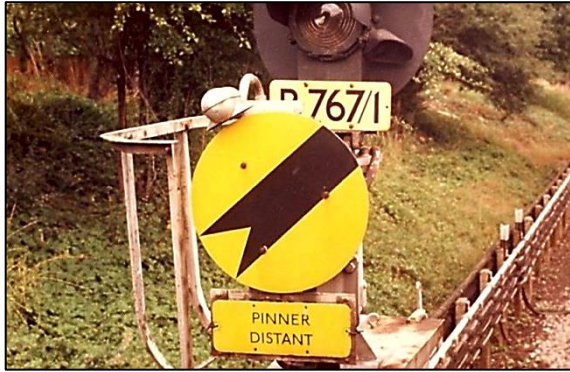
Figure 3: A disc distant signal provided on some lines where main line freight trains operated over the same tracks as Underground trains. This one is on the Metropolitan Line and, to clear, it required A761, A763A, A763B and A767 all clear (the Pinner starter, homes and the next intermediate signal to be off). Note that these signals were not numbered but they were named. They were often mounted on existing Underground signal posts. Photo: LURS Collection.

Another oddity introduced as a result of mixing main line and Underground trains was the distant disc signal. This was an externally lit, circular yellow disc with a black fishtail band (Figure 3). It first appeared on the Northern Line extension to High Barnet, which was opened on 14 April 1940. The branch to High Barnet was originally owned and operated by the London & North Eastern Railway (LNER) and the extension involved tube trains taking over the existing steam hauled passenger services. The line was resignalled to Underground standards with the usual two aspect signals, trainstops and electro-pneumatic point machines.

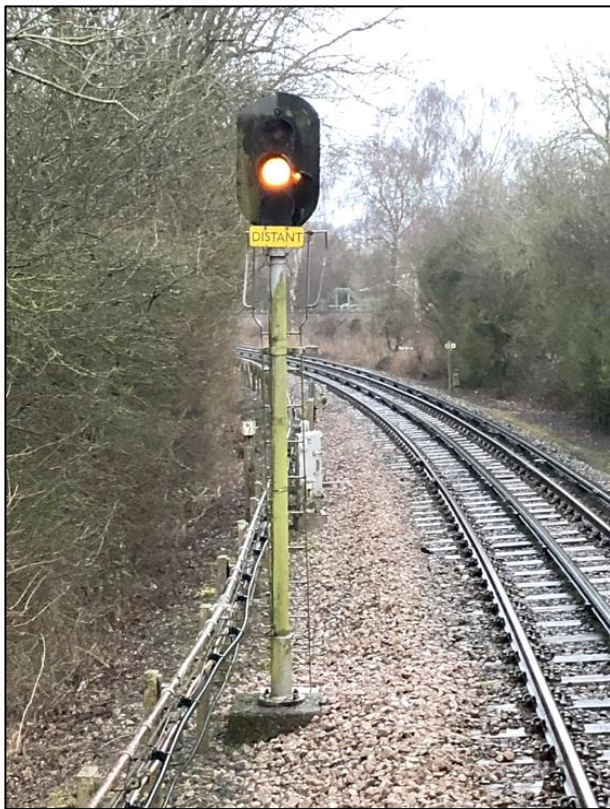
Figure 4: A distant colour light signal on the Chesham branch. This was a fixed yellow signal, with a ‘Distant’ label in yellow in place of an R number. There were two of these on the branch and they were unique to the branch. Photo: B.R. Hardy.

There was one exception to the use of disc distants. This was on the Metropolitan’s Chesham branch, where colour light distants were used. One was provided on the approach to Chesham and one on the approach to Chalfont & Latimer. Both these signals were fixed at yellow as they approached areas where a stop or a reduced speed was required. Curiously, these signals were also originally provided with auxiliary lamps. These showed yellow if the main aspect failed. Like the ones on the Met. main, they fell into disuse.

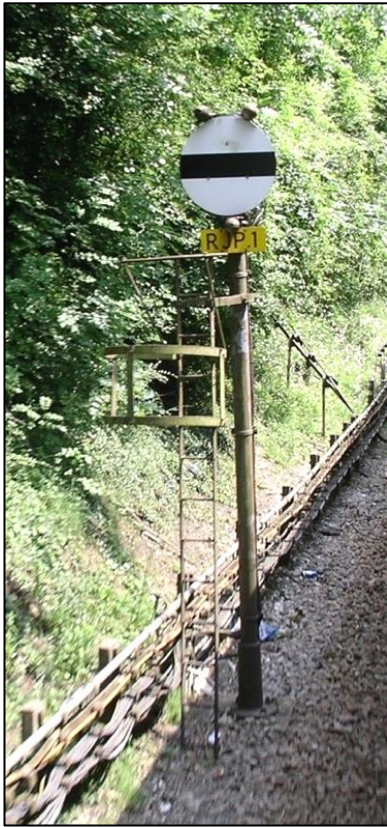
Figure 5: To give main line trains adequate warning of the position of the home and starting signals at Rickmansworth SB, two e.p. operated banner repeater signals were installed on the approach to the station. They replaced two yellow band mechanical banner signals. The new signals were externally illuminated discs, like shunt signals but with a black band on a white ground instead of a red band. The first was for the home signal given a standard Underground repeater number (RJP1, see here in the 'on' position), the second was RJP2 for the starter. Photo: B.R. Hardy.

Related to these distants were the special black on white banner repeater signals installed on the approach to Rickmansworth (Figure 5) for the 1961 resignalling. The approach to Rickmansworth on the up road (SB) from Chorley Wood is downhill and quite fast but it finishes with a serious curve into Rickmansworth station where there is a 25 mi/hr permanent speed restriction. The banner signals replaced the original yellow banner repeaters provided in 1925. These signals were unique on the Underground but banner repeaters are common on the main line and there are examples on the Wimbledon and Richmond branches.

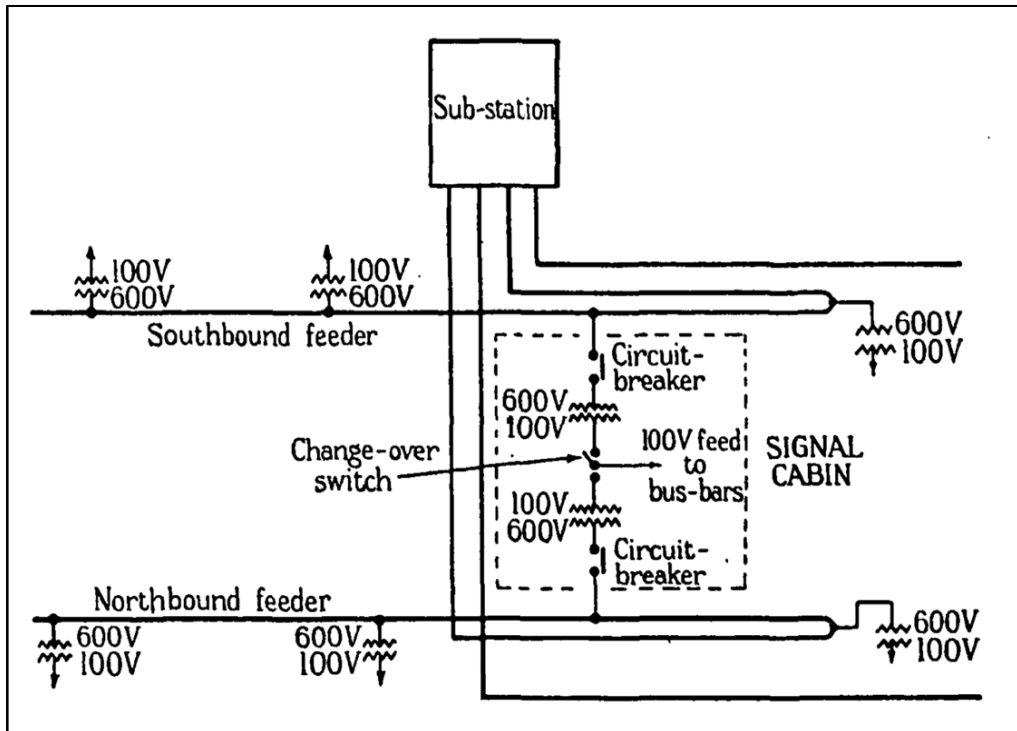
Figure 6: Schematic of Underground power supplies provided for the signalling systems and signal boxes. A transformer is provided at each supply point and links ensure that every tap becomes a point at which the supply can be isolated. Separate transformers were provided to step the voltage down to 100 volts for signalling and track circuits. Each could be isolated by means of the links while all remaining signal equipment was left in operation. Drawing from Dell (1944), *Developments in Railway Signalling on London Transport Proc. Inst. Electrical Engineers*.

The supply voltage tended to vary from one place to another, so the Metropolitan originally had 130-volt and 60-volt supplies but later it converted its supply to 440 volts Alternating Current (AC). The Underground group followed much the same pattern, starting with DC supplies and then going over to AC. Eventually, the Underground standardised on 600 V AC. The system hasn't altered much to this day, the basic layout of supplies appearing as in Figure 6 below.

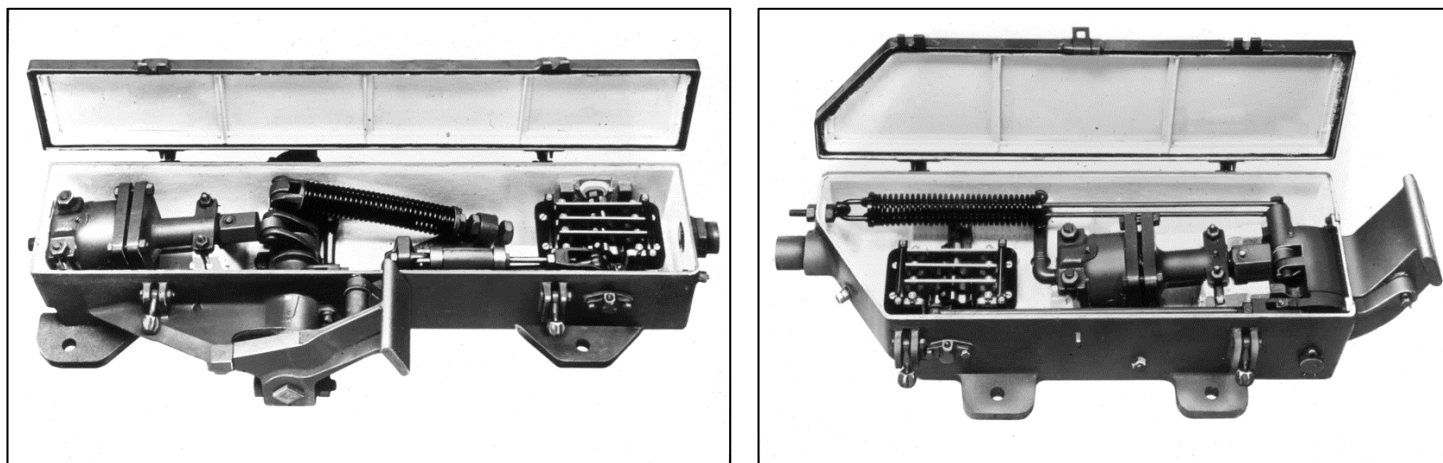
Figure 7: Westinghouse official photos of their new trainstop designs circa 1932. The HO type on the left is a straightforward rectangular box for outdoor use containing, from left or right, the air cylinder, the crank to operate the trainstop, the return spring and the detection contacts. The operating valve was mounted separately. The trainstop arm is on the side of the box. The HT type on the right is a more compact version designed for use in tube tunnels. The trainstop arm is at the end of the box. Photos: Westinghouse Archive and Chippenham Museum.

As early as 1911, Westinghouse produced a design for an enclosed electro-pneumatic trainstop¹⁰ but it was contained in a substantial rectangular steel box and it probably would have been difficult to fit without providing at least two extended sleepers at each location and it wouldn't have fitted in a tube tunnel. Also, it was too wide to fit in the 4-foot without cutting the negative rail. In 1931, a much improved enclosed design, more suited to conditions on the Underground, was offered by Westinghouse. This was the Style H trainstop. It came in two basic designs, described by Westinghouse as the H3 and the H4 (Figure 7). The H3 became known on the Underground as the HO, ('O' for outside) while the H4 became the HT ('T' for tunnel). The HO was designed for surface operation, comprising a long rectangular box with the trainstop arm protruding from the long side, while the HT had the arm at the end of the box. This was a more compact design and was immediately identified by the rear end of the box being angled. Photographs of the time suggest that the new Style H trainstops were first installed in 1932 for the Piccadilly Line eastern and western extensions.

Over the following decades, various improvements to these original designs appeared. They included the Style J outdoor type, an improved version of the HO with an oil pump for lubrication, the Style K tube tunnel design based on the HT, also with a self-lubricating system included in the unit, and a Style KC unit designed to fit on the wall of tube tunnels with restricted space at rail level as found on the Central Line. There was another version, known as the Style KF, which was a modified version of the Style K for use in areas with flat bottom rail¹¹. A few locations were also provided with modified Style J designs. The Underground's designations for the variations in trainstop design included a modified outdoor Style H3 known as the H5 and a modified indoor Style H4 known as the H6.

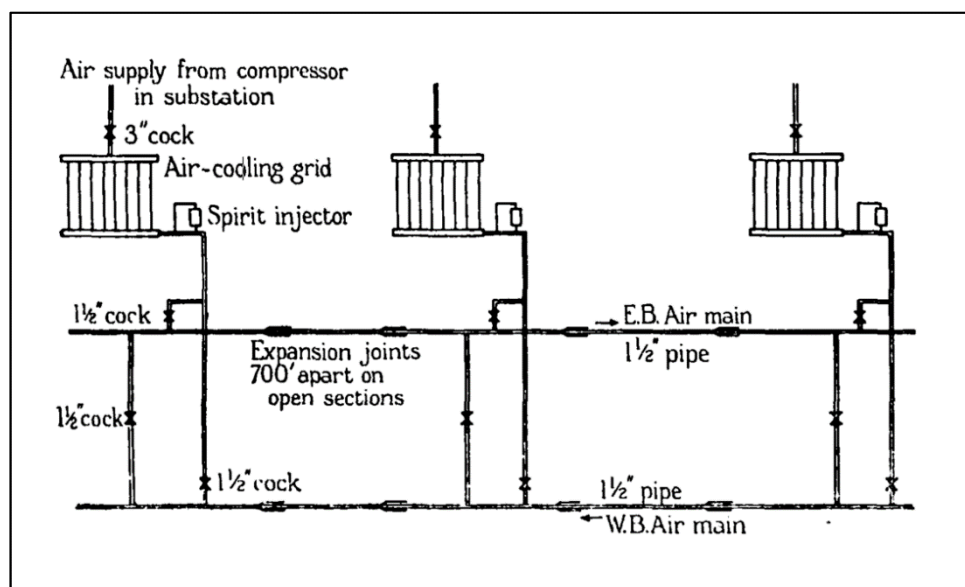
Figure 8: A simplified diagram of the standard Underground air supply system. Originally, de-icing spirit was used to stop the moisture from freezing in bad weather. Nowadays, they use glycol. Drawing modified by P. Connor from Dell (1944), *Developments in Railway Signalling on London Transport Proc. Inst. Electrical Engineers*.

The Underground's reliance on electro-pneumatic signalling equipment meant that a network of compressed air supplies was required. Compressors were installed at all substations and provided a constant supply of compressed air to the 1½ inch diameter main air pipe run throughout the system. As with the electric supply system, it became the practice from the 1930s to duplicate the steel compressed air supply pipes so there was one on each side of a pair of tracks¹². The pipes were mounted on concrete posts set alongside the track at 4-foot intervals and they were used as a rail that provided a convenient support system for the signalling cables. The pipes had special brackets hung off them on which the cables were slung. The pipes were supplied in 11-foot lengths and, where there was an e.p. operated device, it was connected to the main by a half-inch flexible hose. The compressed air output from the compressor was originally passed through cooling grids to encourage the moisture to drain off and isolating cocks are provided wherever a tapping is taken off to allow isolation in case of a leak. Later, the cooling grids were abandoned in favour of air dryers installed inside substations, although the grids were often left in situ. Of course, the pipework for the air mains had to be protected from temperature changes and special expansion joints were fitted in the pipes at intervals to compensate.
