THE ONGAR SHUFFLE

by Eric Stuart

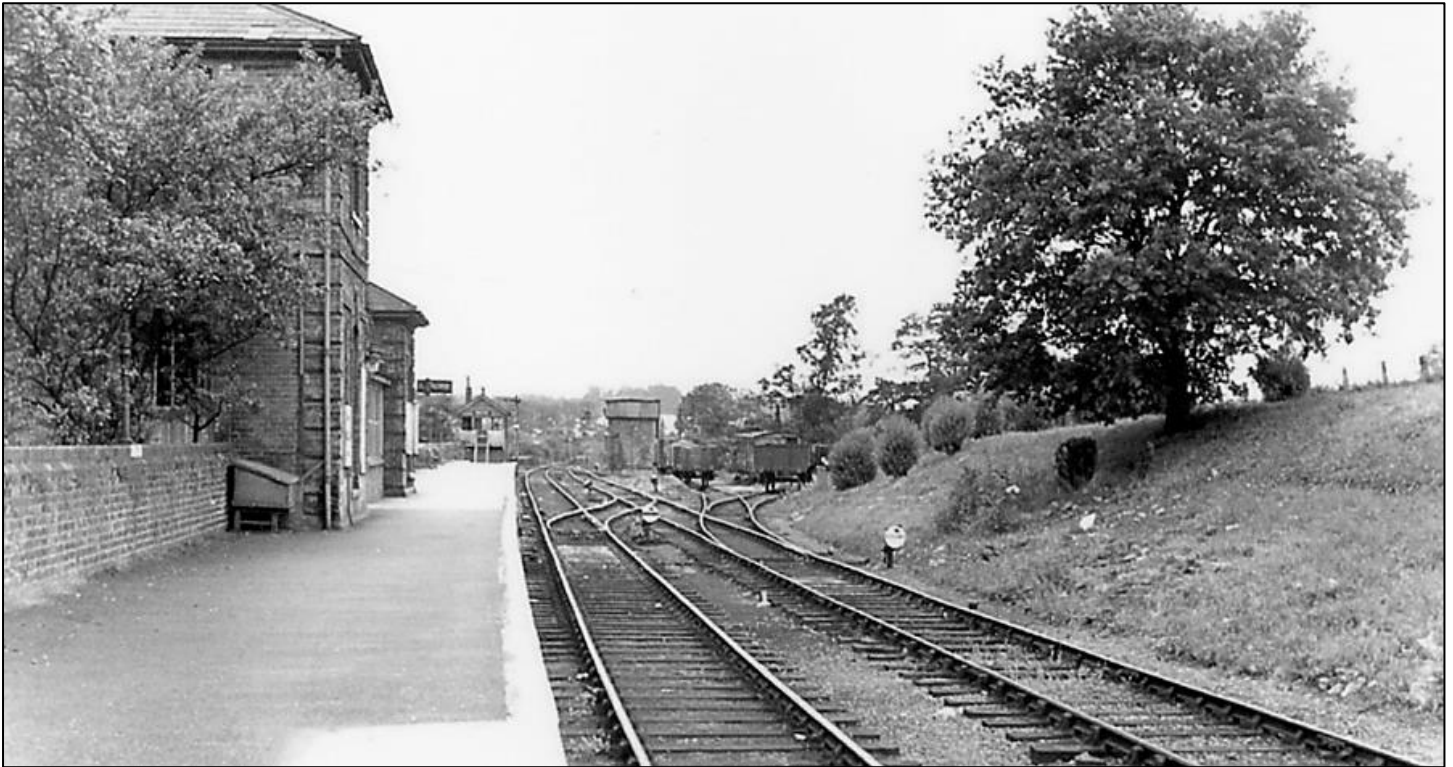
Above: A general view of the station layout at Ongar from the buffer stops looking towards Epping and before electrification. The loop crossover can be seen midway along the platform, which would be used by arriving trains during the three-train service.

However, by dint of a comparatively simple change of signalling and points at Ongar, three levels of service would be possible. The most noticeable alteration was the removal of the cross-over at the east end of the platform and the placing of one in the middle of the platform. The three levels of service then possible were:

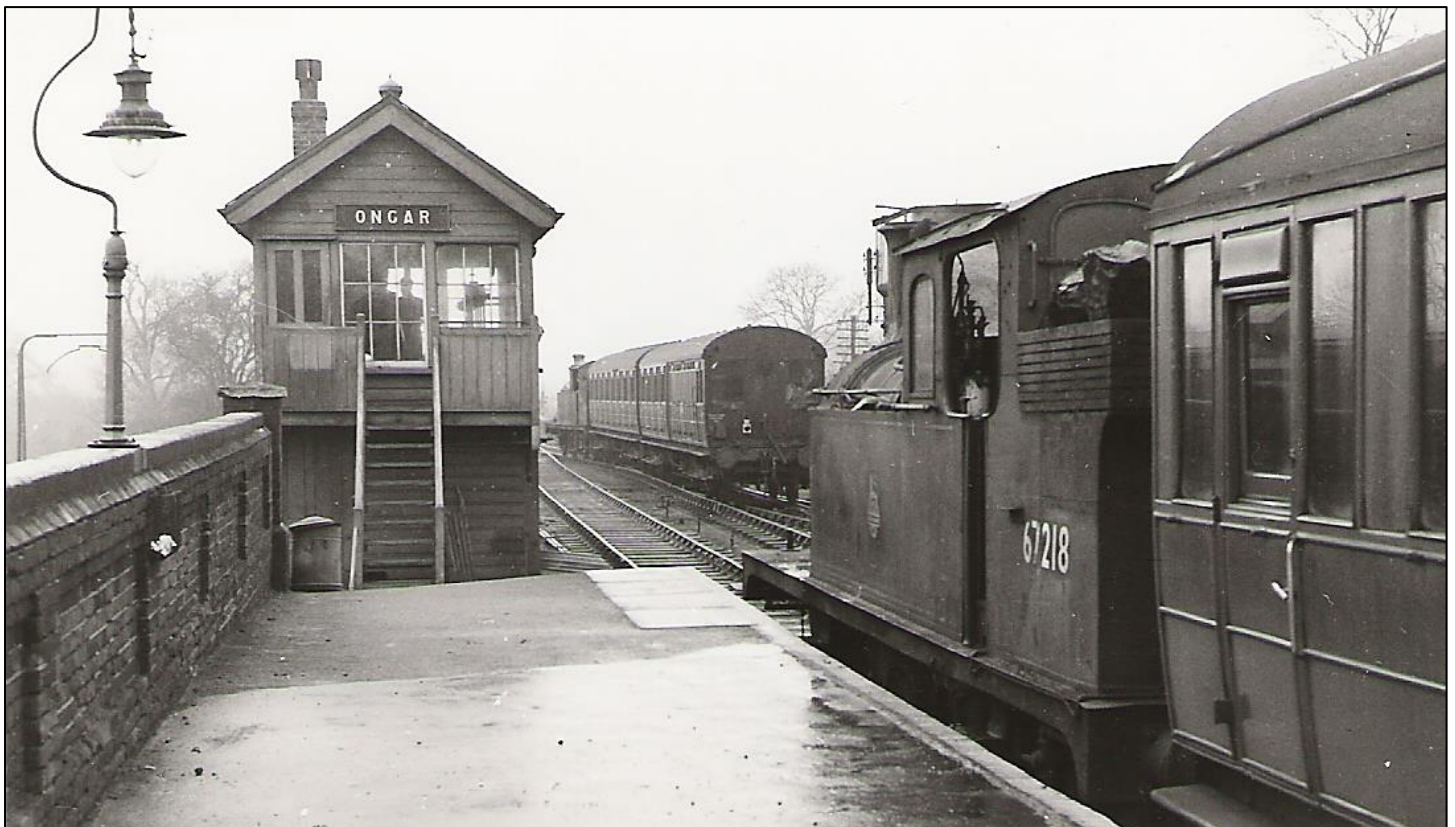
Below: Looking towards Epping from the 'London' end of the single platform with the signal box to the left. Also in pre-electrification days, one of the push-pull shuttles approaches on the loop road, which will pass the departing train on the right and run via the crossover to the far end of the platform.

Firstly, Train 1 leaves Epping. It proceeds to North Weald, where it crosses Train 2. Train 2 continues to Epping and Train 1 to Ongar. At Ongar, Train 1 enters the station by the former engine release line (see *photo page 44, Lower*), passing Train 3 waiting at the west end of the platform with departing passengers aboard. It moves over to the platform road at the crossover in the middle of the platform (see *photo page 45 Top Right*) and stops at the east end of the platform for passengers to get off. Both Trains 1 and 3 are now in the platform (see *photo page 45, Lower*). Now that the single line is clear, Train 3 can leave, passing Train 2 at North Weald, on its way back from Epping.

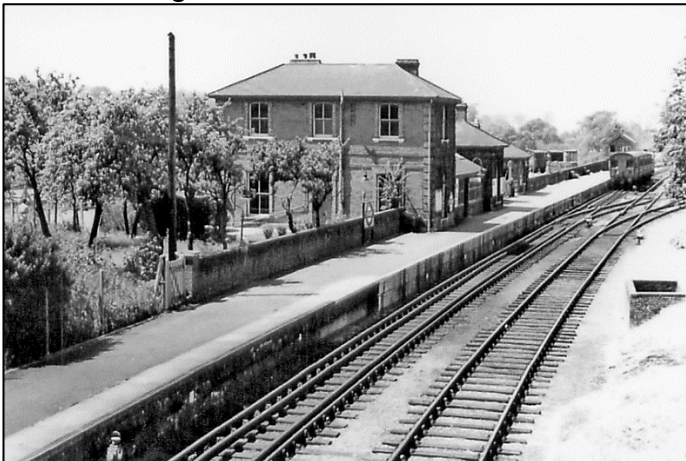
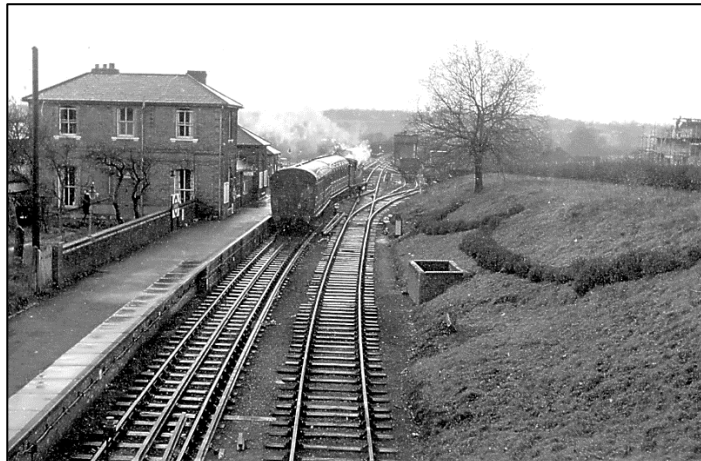
Opposite: (Top) Two views of the arrangements at Ongar between September 1949 and November 1957. A departing train waits at the far (London) end of the platform (Left), while an arriving train crosses from the loop to the end of the platform (Right). Note that current rails are in situ just prior to electrification. The signal box here closed on 23 March 1969 and was subsequently demolished, control being from North Weald.

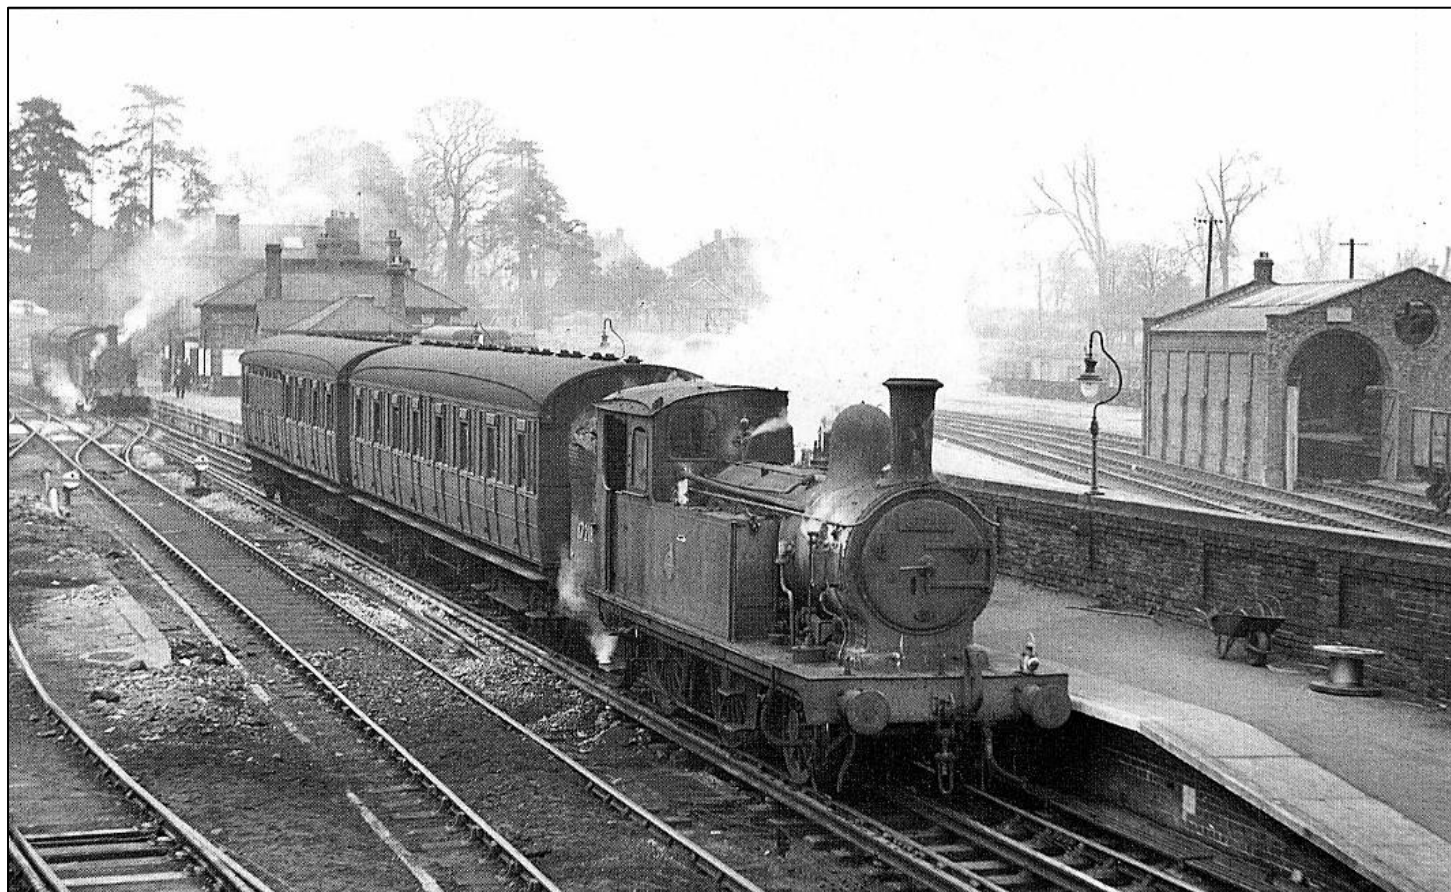
Above: Two push-pull sets in the platform at Ongar, that nearest the camera awaiting departure for Epping. The train in the distance has just arrived, having run via the loop and across the crossover in the distance to the far end of the platform. After the nearest train has departed, it will then run forward to that position and await the arrival of the next push-pull set from Epping. Current rails are already in position for electric services.

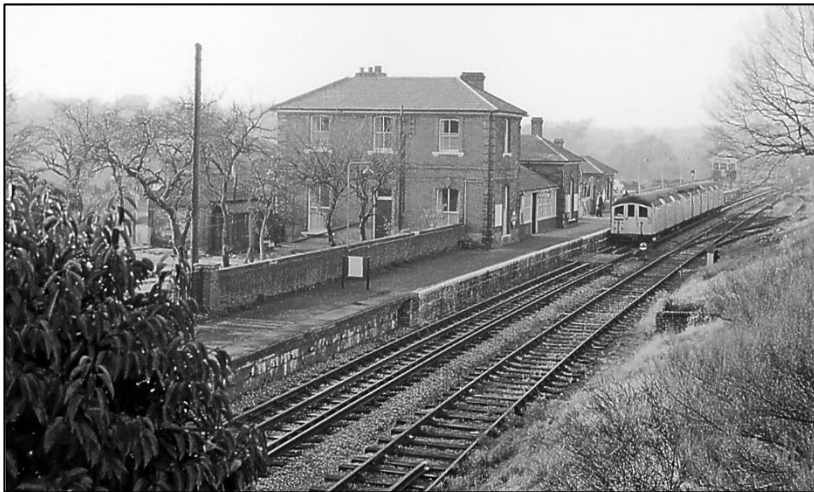
Left: Ongar in electric days, post 1963, which is from when the 1935 Stock was repainted silver, looking down from the embankment at the end of the line. The loop crossover has been removed and the loop has become a long siding.

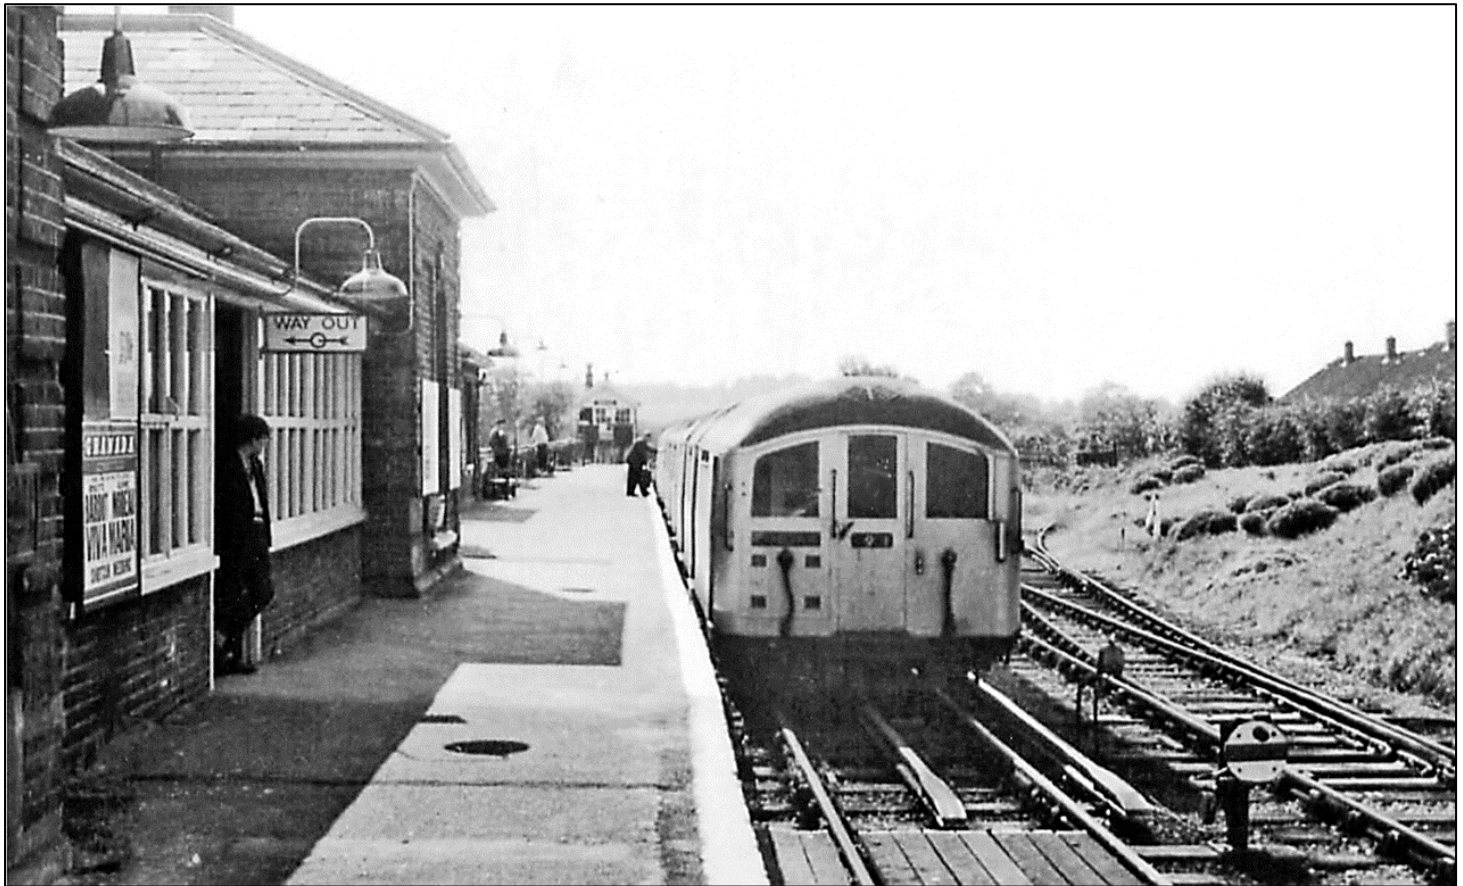
Below: 1935 Stock DM 11010 stands at the normal stopping mark at Ongar. Beyond the wooden boards behind the photographer was a berth for stabling a defective train, which was then a signalled move, in and out.

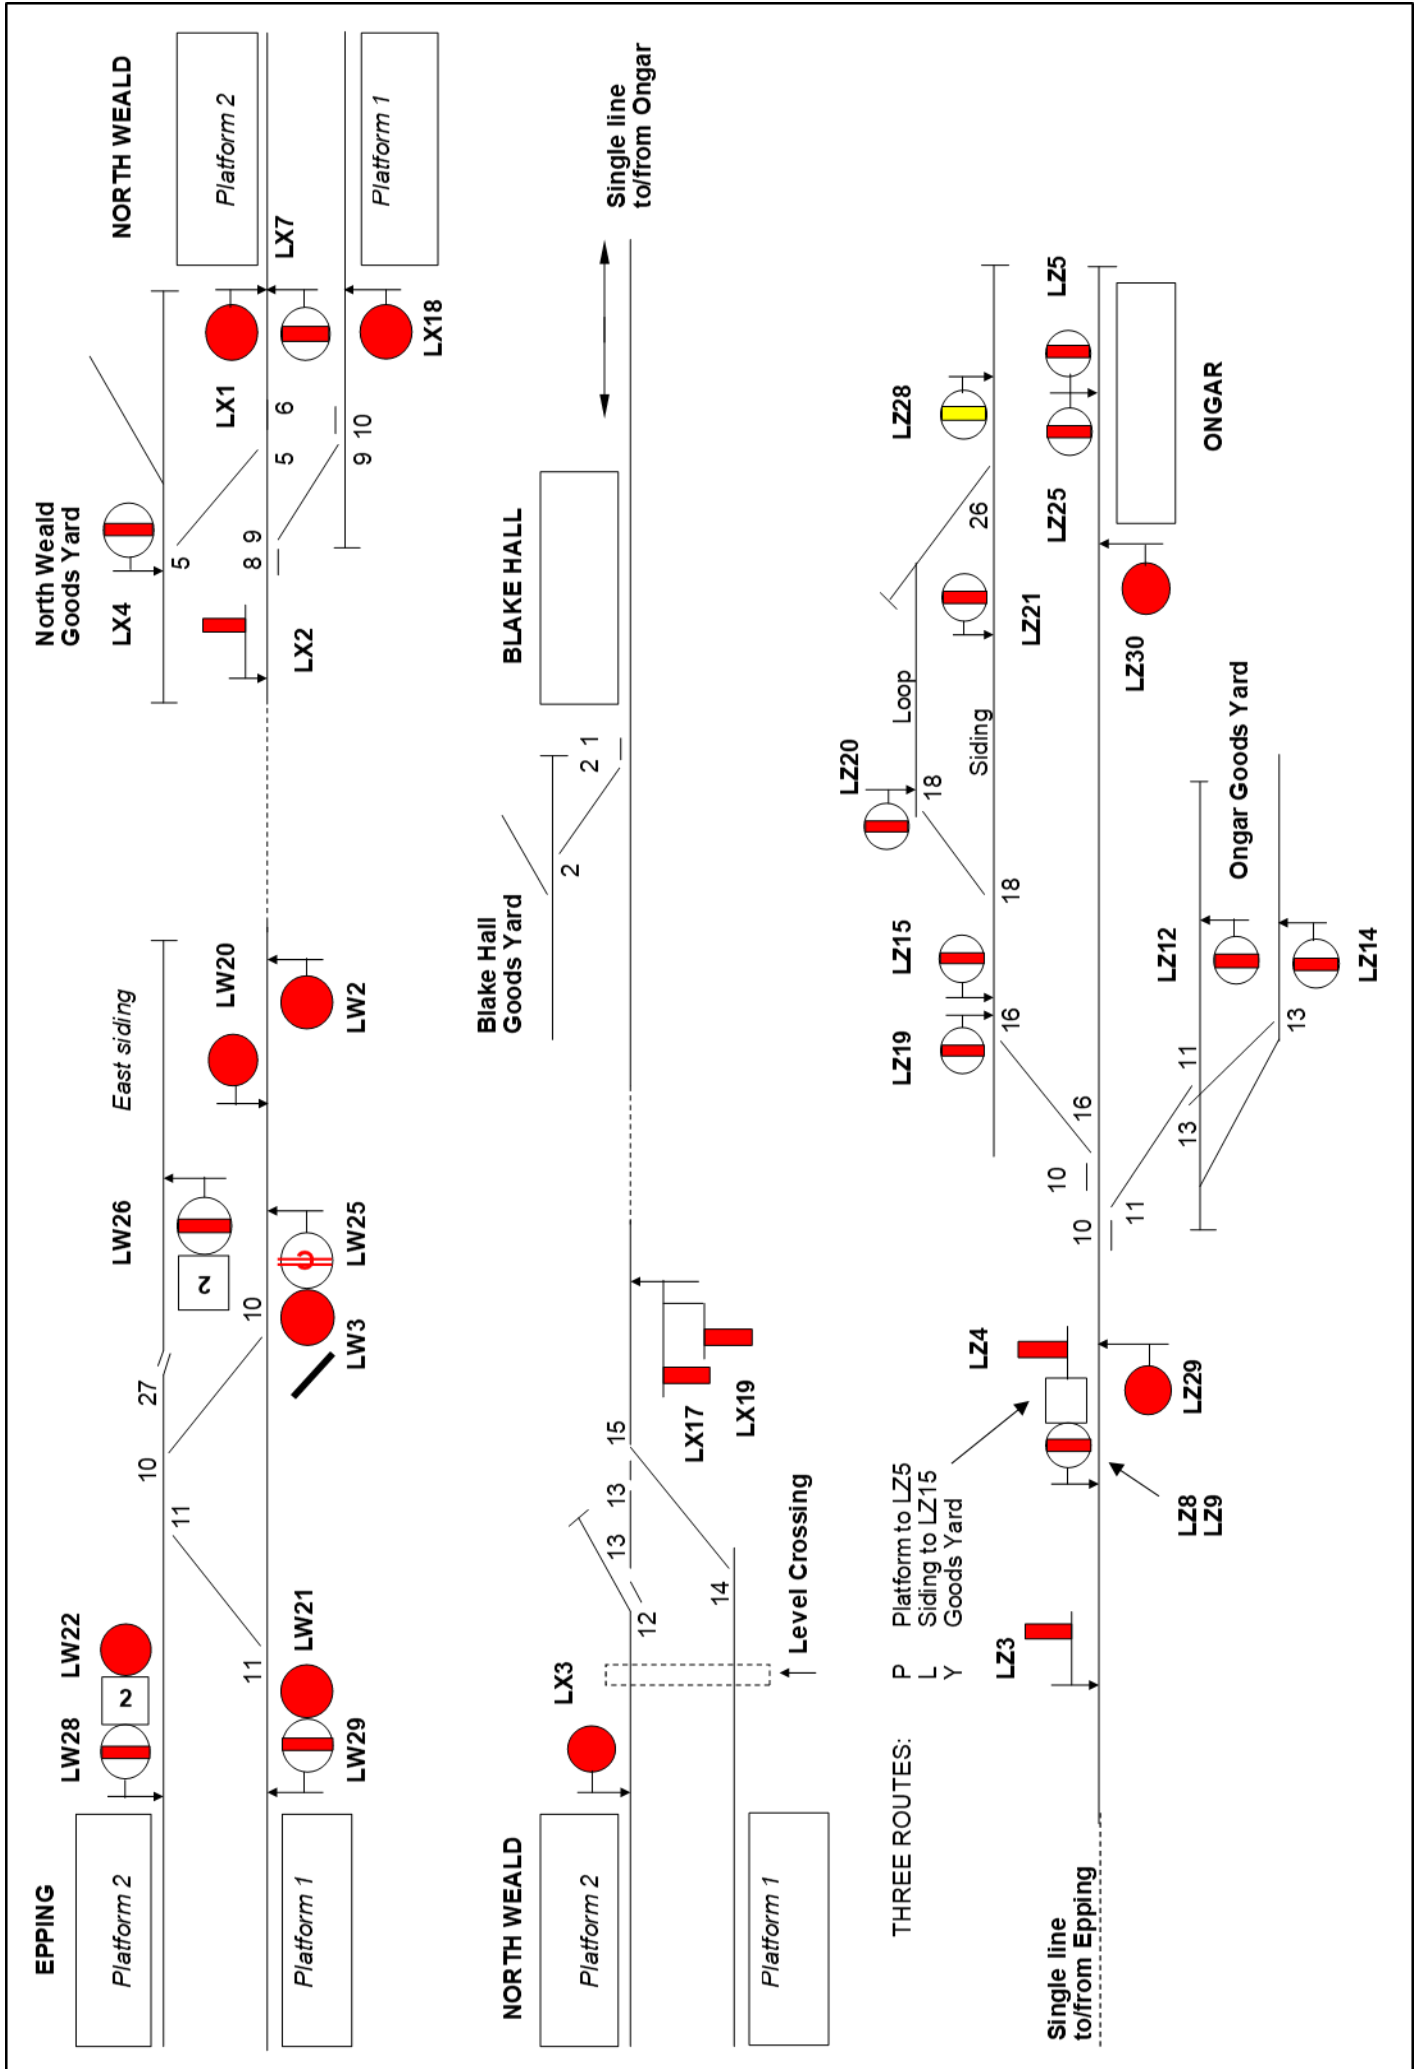
Opposite: Signalling and track plan of the Epping – Ongar line as it was from electrification on 18 November 1957.

Left: A two-car unit of 1935 Experimental Tube Stock at Ongar in the very early days of electric services. The train has stopped short of the overrun section (see diagram) which was provided to stable a defective unit if necessary. Note at the bottom left, the severed remains of the points, which were used by steam trains to run up to the far end.

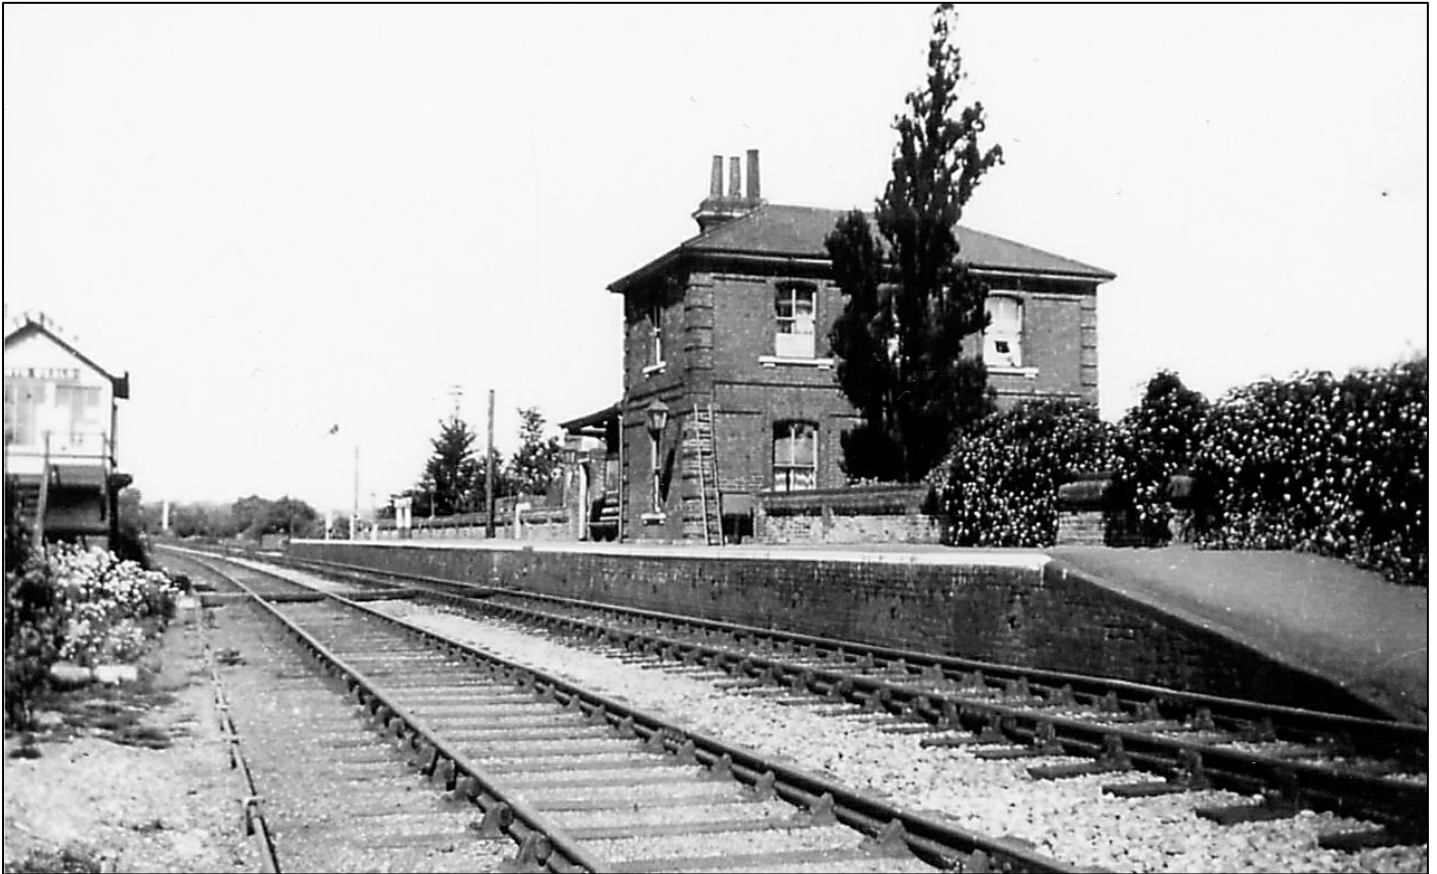
Above: An undated view at North Weald but certainly pre-1949 and before the loop platform was built. The track to the left was a long siding and it wasn't possible for trains to be 'looped' here.

Although Epping has (and had) two platforms, the eastbound platform would normally be occupied by a reversing Central Line electric train, passengers crossing the footbridge to and from the connecting Ongar shuttle. There had been a long siding at North Weald, but this was altered to a passing loop, with a second platform added, in time for the new service.

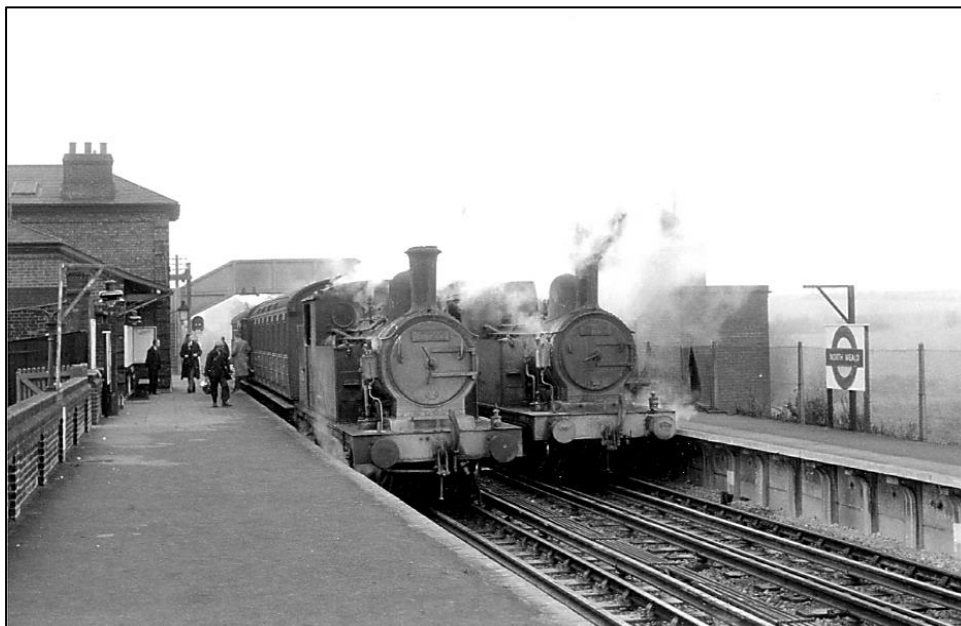
Left: In the closing days of steam push-pull working between Epping and Ongar, two trains pass at North Weald, with current rails already in position. Steam working ended on 16 November and the following day, the signalling was changed to adapt for electric

train working after which, trial running took place. Public services with electric trains between Epping and Ongar began on Monday 18 November 1957.

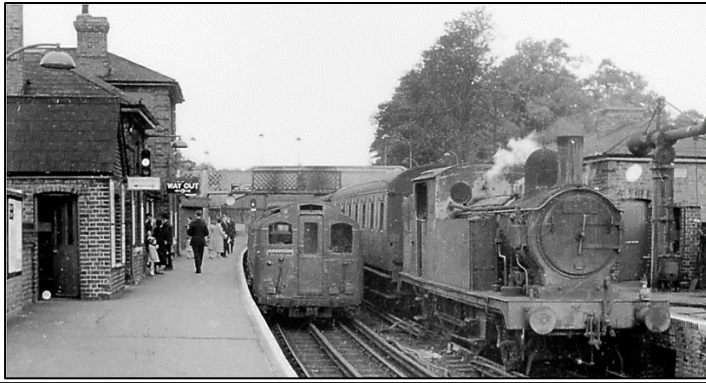
Left: The steam push-pull from Ongar is in platform 1 at Epping on the right, while one of the Loughton shuttles composed of Pre-1938 Tube Stock waits in platform 2 – this complimented a then sparse through off-peak Central Line service to and from London. The quality of booked connections between the two shuttle services was variable, to say the least. The need for the Loughton shuttle reduced as traffic increased.

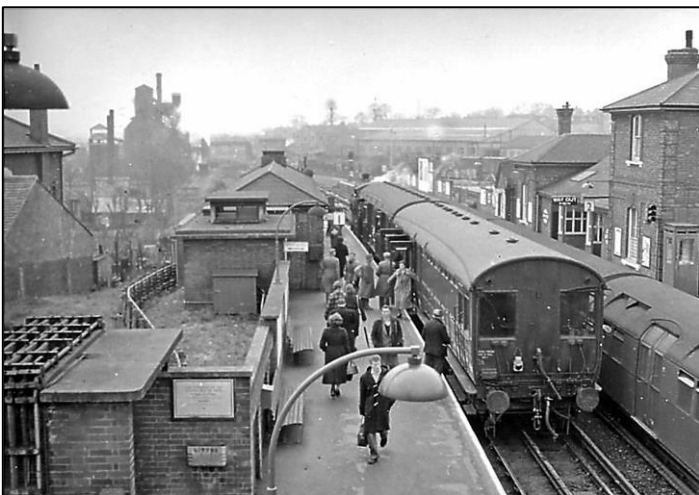
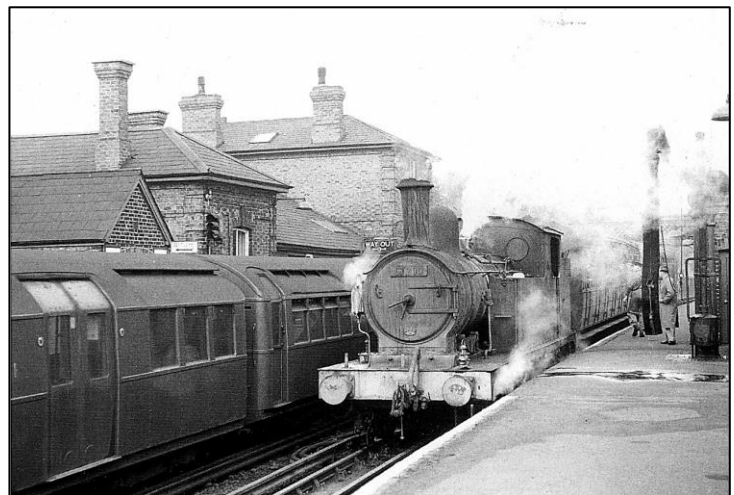
Below: Connecting at Epping. Two views of the Ongar steam shuttle at Epping, connecting into and from Central Line trains. Passengers alight from an arriving train (Left) and have to cross the footbridge to continue into central London – the Central Line train is waiting in platform 2 on the right with part of a 1927 MCCW control trailer visible. Wheezing steam, the push-pull shuttle stands in platform 1 with a Central Line train to the left, showing part of a 1923 Birmingham trailer and part of a 1924 MCCW motor car. The water column to replenish the steam locos is on the right.

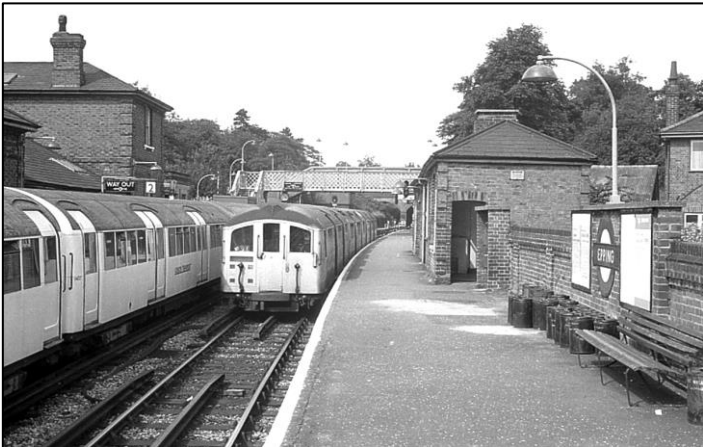
Above: Connections at Epping in the 'silver' era, with a train of 1935 Experimental Tube Stock having arrived in platform 1 from Ongar, while a 1962 Tube Stock awaits departure for London and the west on the left. In front of the train are the gaps in the current rails for coupling and uncoupling. The water column provided on the platform for steam trains has long since been removed, even though freight is still operating (just) but diesel hauled.

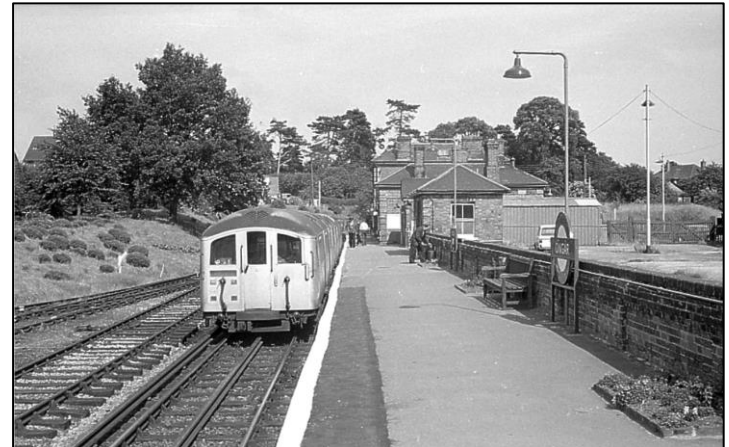
Above: The Experimental 1935 Tube Stock was repainted from red to 'silver' in 1963 (two units) and 1965 (one unit), the latter being later because of it having reduced mileage with it being on test train duties for a few years. Seen at Ongar and waiting for departure for Epping, it will be noted that by now, LT bullseye signs are in place, unlike when the line was first electrified (see photo, previous page, lower).
