LONDON UNDERGROUND SIGNALLING

39. THE CENTRAL LINE PROJECT

A NEW APPROACH

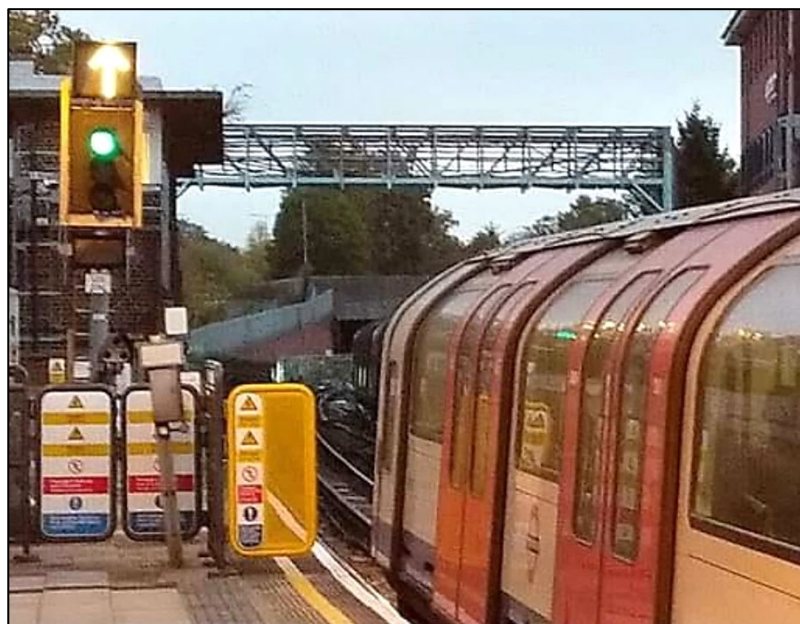
Figure 1: A 1992 Tube Stock train about to depart from the EB platform at Leytonstone, the starting signal showing the 3-aspect signals used to provide proceed indications for both manually driven and automatic trains, like those on the Victoria Line. The Central Line upgrade project of 1990-2005 included the 1992 Tube Stock and new ATC signalling installed by Westinghouse. Note the new style of route indicator introduced on this line with an illuminated arrow indicating each direction rather than three while lights being shown only for diverging routes. The arrow seen here indicates the route straight ahead. Unlike the older route lights, these new indications were not required to be proved. Photo: Phil Wimbush.

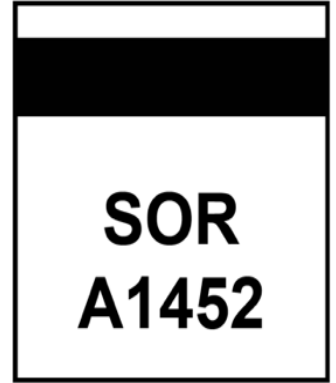
Figure 5 (above right): A signal identification plate for an automatic visual signal on the Central Line. The code letters refer to the area, in this case, South Ruislip. The signal is the westbound home.

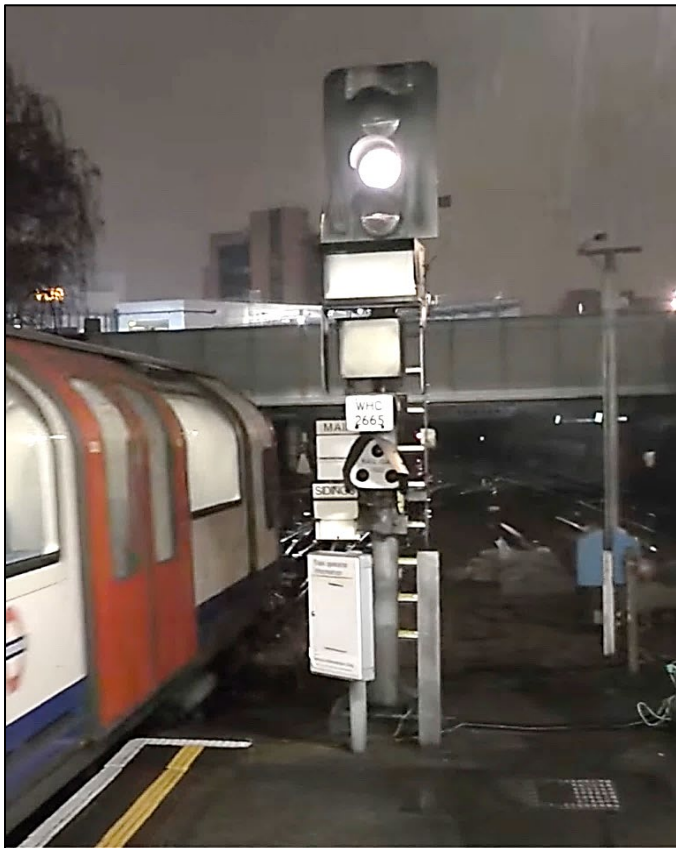
Figure 7: An example of a 3-aspect signal on the Central Line at White City. It has its aspects arranged from the top as Green, White and Red. The white aspect is shown for the departing train, which is in ATO mode. Trains in coded manual are not permitted to pass the signal unless a green aspect is shown. Below the signal is the 'Route Secure' sign and below this is the square sign where a shunt signal is displayed if required. The signal number is on a small rectangular plate, showing WHC 2665. Below that is a triangular rail gap indicator. Photo: Still from YouTube video by x2k9.
