LETTERS TO THE EDITOR

R STOCK – UNDERGROUND NEWS No.735

A STOCK ROOF COLOURS

MERCURY TUBES AND NORTHERN CITY TRANSFERS

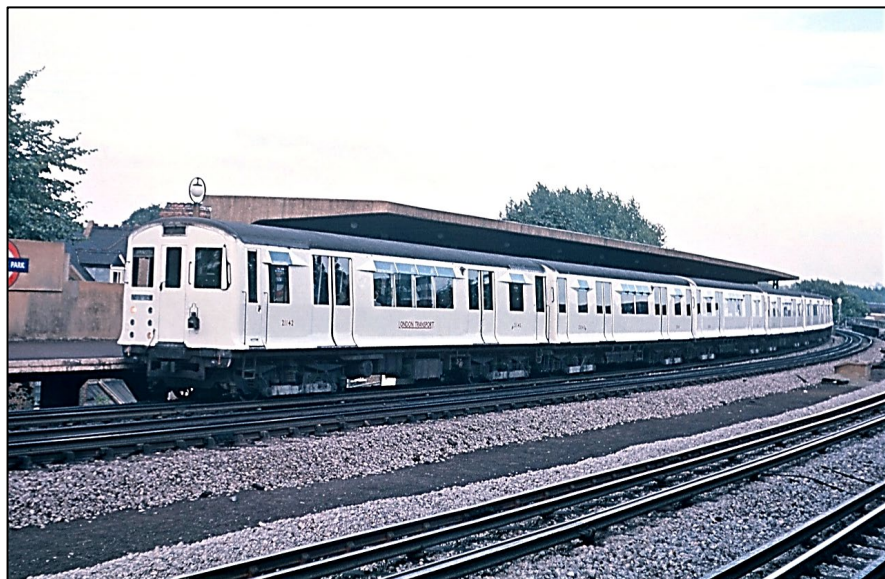
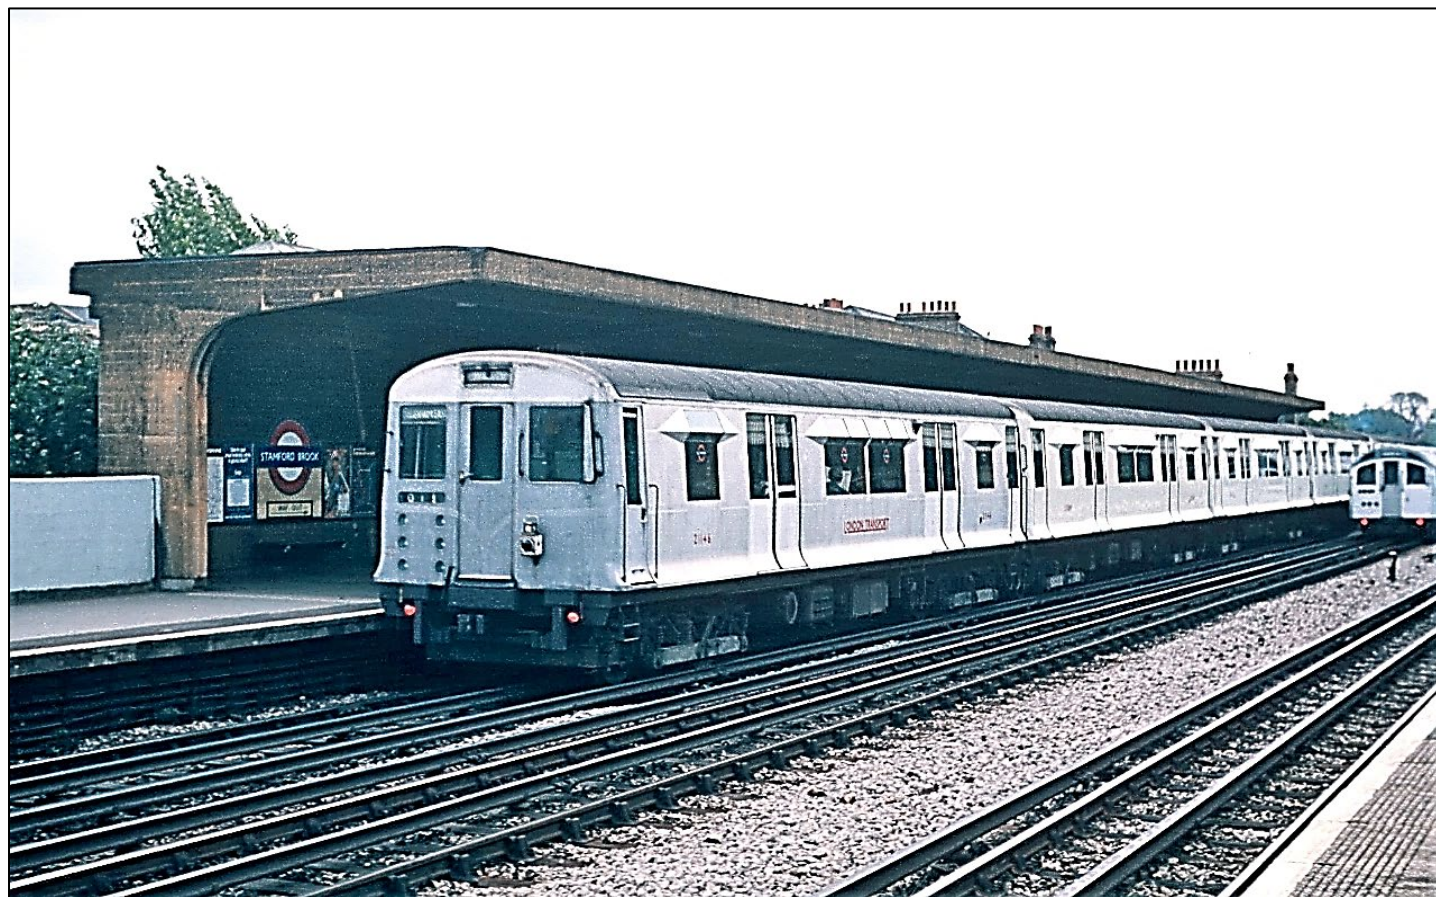
Although many people may not have been aware, the R49 Driving Motor cars differed in layout from their R38 equivalents.

The centre section between the two sets of passenger doors was shorter on the R49 DMs than on the R38 DMs, with an equivalent increase in length of the section between the forward doors and the driver's cab. This resulted in a large blank panel between the driver's cab door and the first side window on the R49s, whereas on the R38s the door and side window were adjacent. This can be seen by comparing the views of R38 21142 at Chiswick Park (*Left*) on 8 September 1975 with R49 21146 (*Below*) at Stamford Brook the following day. The shadow

of the red V and stripe are clearly seen on 21146, as is the painted canopy over the end windows.

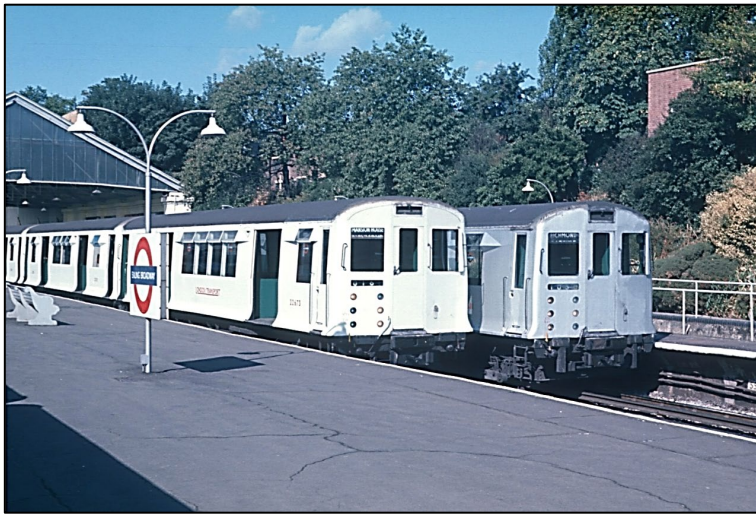
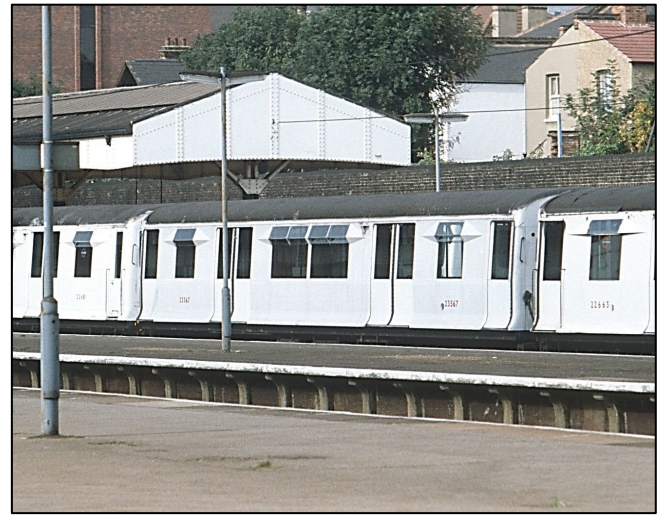
As another comparison, R38 22673 is seen at Ealing Broadway on 10 September 1975 in white livery alongside R49 22681 in painted silver livery (*Above, Left*), which not only contrasts the differences in the window layout between the two cars, but also the two different painted liveries. The first unpainted car, 23567 is seen towards the end of its life at Wimbledon (*Above, Right*) on 4 September 1982. Interestingly, it is coupled to R49 DM 22681, this time in white livery, which appears again.

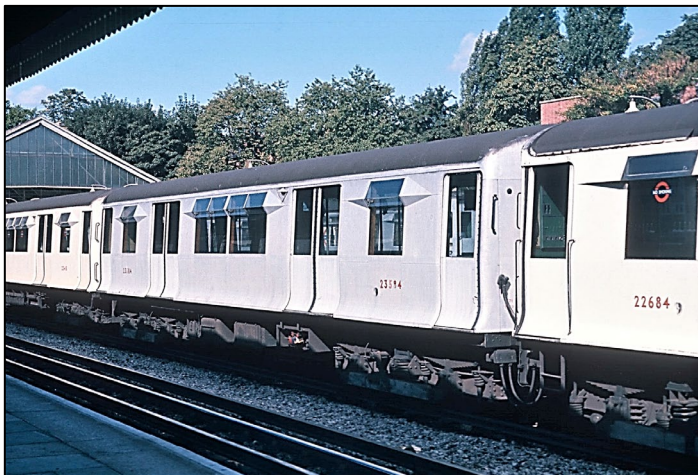
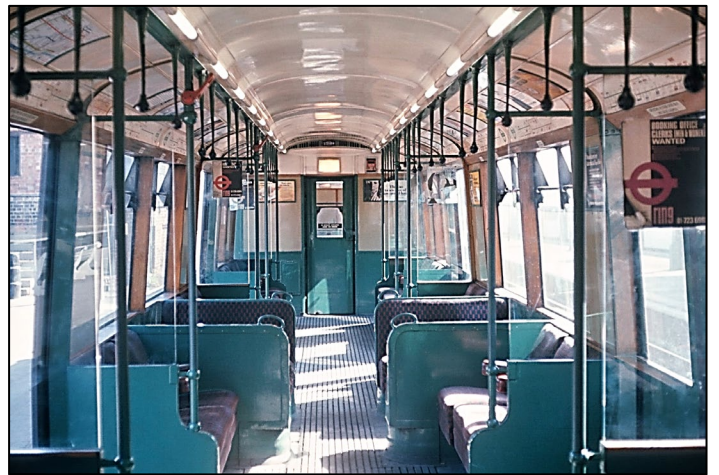
A little-known celebrity was unpainted R59 NDM 23584 seen at Ealing Broadway (*Below, Left*). This was the car which went to the Aluminium Railway Vehicle exhibition in Strasbourg in France in June 1960. With the exception of the Metropolitan Railway rigid 8-wheelers which went to France, was this the first Underground car to go overseas? An interior view (*Below, Right*) shows that, at least in 1975, it did not seem to have any commemorative plaque inside, unlike 23567. Was there one originally?

As a comparison (*Left*), here is a view of R38 22606 alongside CP Stock 54244 at Ealing Broadway on 10 September 1975, which demonstrates the differences between the two types. By coincidence, 54244 was one of the two P stock cars which, as 14244, played its part in the development of the R-Stock. Along with its partner, 13244, it was fitted with florescent lighting between 1946 and 1955 as a trial for the R-Stock. Its leading bogie was also equipped as a trial with retractable shoe gear, which was adopted for, but later removed from, the R Stock.

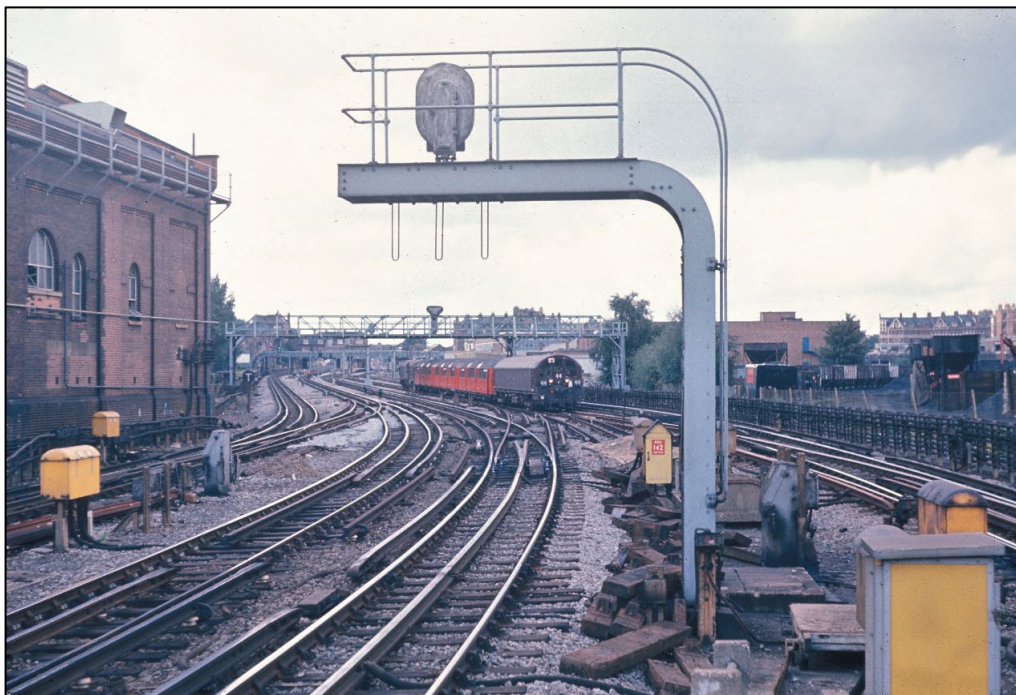
As a result, the signal gantry on the approach to Finchley Road was equipped with three glass U-tubes filled with mercury, designed to break and therefore return the signal to danger, if a surface stock train attempted to enter the Bakerloo Line platform. The gantry and U-tubes can just be seen in the background of the bottom photo on page 224.

A better view is in the photo (*Left*) which also shows battery loco L44 (BR Doncaster 1973) approaching the southbound Metropolitan Line platform on 11 September 1975 with a three-car train of 1938 Tube Stock being transferred from Neasden depot to Drayton Park on the Northern City Line. I believe that this was the penultimate such working before LT operation of the Northern City Line ceased in October. The train is coming off the loop which

existed between the Metropolitan and Bakerloo Line tracks between West Hampstead and Finchley Road, having evidently travelled on the Bakerloo track from Neasden, and the points giving access to both lines from the loop can be seen. Battery loco L56 (Pickering 1952) was at the rear.

These days, the tubes are painted with a silver conductive paint, as mercury is now prohibited on Health & Safety grounds. The breaking of the tubes would cause the protective trainstop to remain up (and the signal, if there was one, would return to danger). There is a popular myth that the breaking of the tubes would also take current off – this is not so. (It was always taught at the Railway Training Centre that taking current off would not stop a train). Regarding the detector at Finchley Road, Fred Ivey related a story to me about when he was on duty at Finchley Road as Station Manager, assisting with the return football traffic from Wembley. He received a telephone call from Wembley Park saying that a football supporter's flag pole was sticking up between a pair of communicating doors on a southbound Jubilee Line train. But, too late, the train arrived and smashed the tubes, putting the service into chaos.

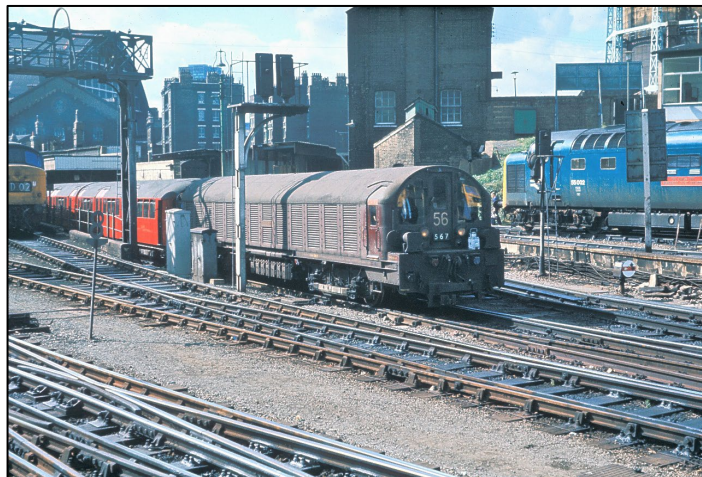
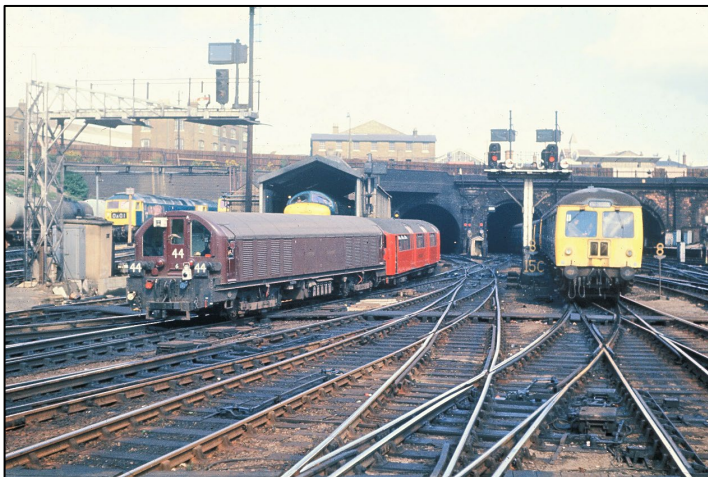
The same train was photographed a little later (*Below, Left*) passing through the Down suburban platform at King's Cross, having climbed the curve from the Widened Lines with L56 now leading and with a Class 46 Peak diesel and the now-preserved Deltic 55002 "The King's Own Yorkshire Light Infantry" also present, and then leaving Kings Cross main line station (*Below, Right*). On the left are Class 47 diesel locos, with another Class 55 Deltic behind the train and a Cravens Class 105 DMU arriving.
