STATION REFURBISHMENT SUMMARY

as at mid-February 2009

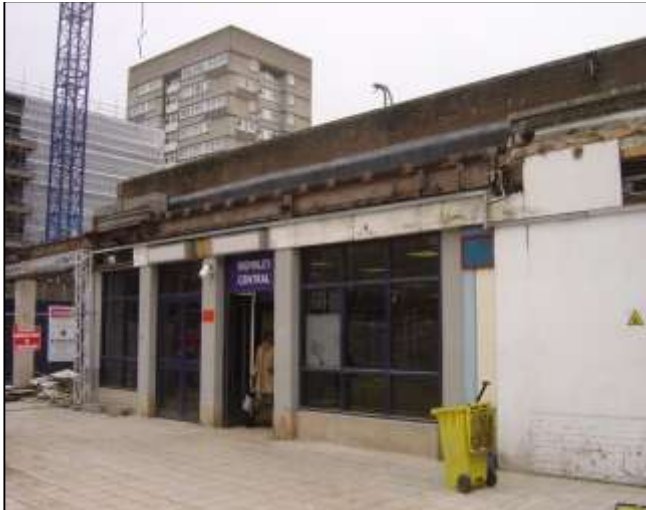
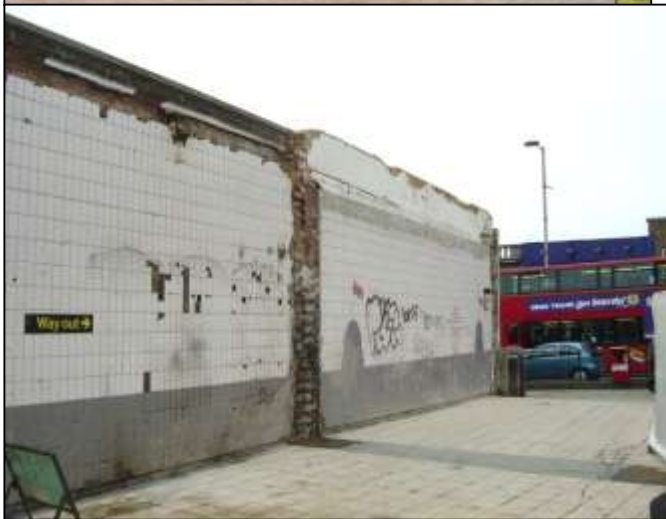
WEMBLEY CENTRAL – The remaining 1930s LMS entrance building in the High Road (see *Underground News* No.560, August 2008, page 560) was demolished in early February, only receiving new signs a couple of weeks beforehand!

Below: These two photos of Wembley Central were taken on 12 February 2009 and show the temporary 'main' entrance (*left*) and the view looking out at Wembley High Road (*right*). The furthest wall still retains two of the silhouettes of the former Wembley Stadium 'towers', but probably not for much longer.

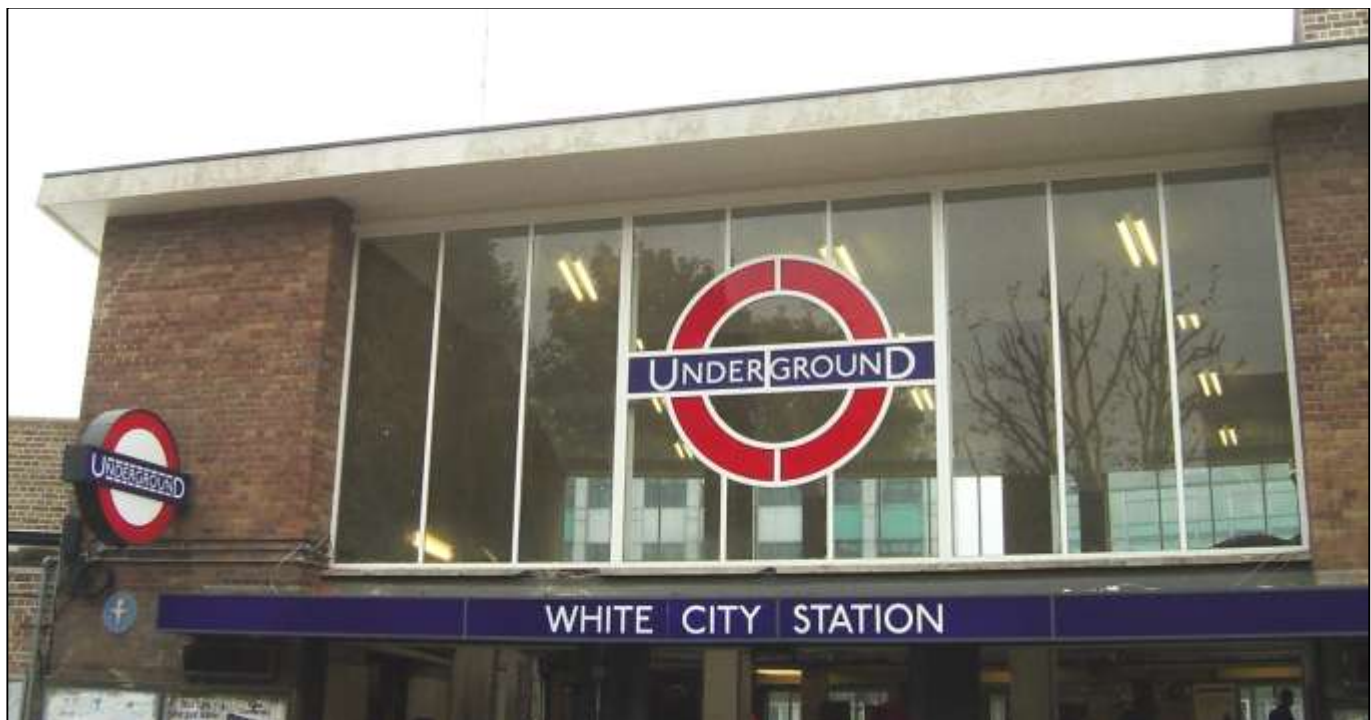
Below: The 'restored' station entrance at White City. The Underground signs at right angles to the building (one of which is seen at the left-hand-side), although in heritage style, are not in keeping with a post-war station which opened in 1947. Nevertheless, the incorporation of 'heritage' features is to be commended. On 5 February 2009 the sign at the left of the photo had been removed but that on the right (out of the picture) was still in position.

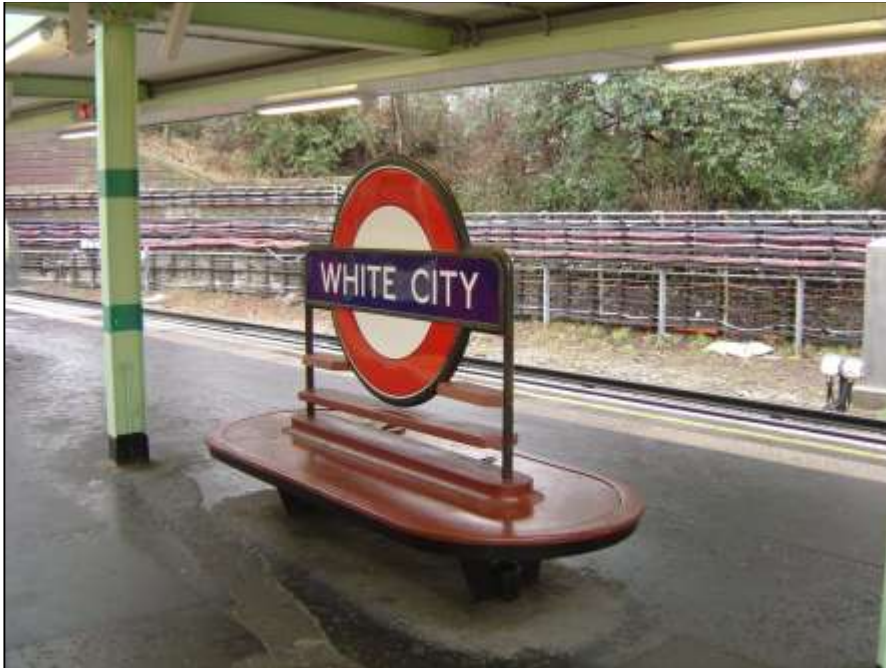
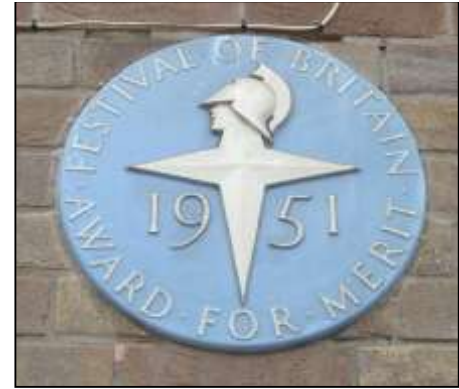
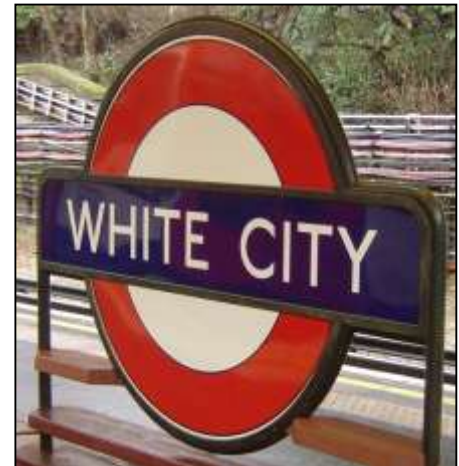
The restored combined seat/roundels at White City (*above*) although the roundels themselves (*right*) are 'lined' whereas at least some of the previous ones were not. The plaque commemorating the Festival of Britain in 1951 (*above right*) has been retained outside the station entrance.

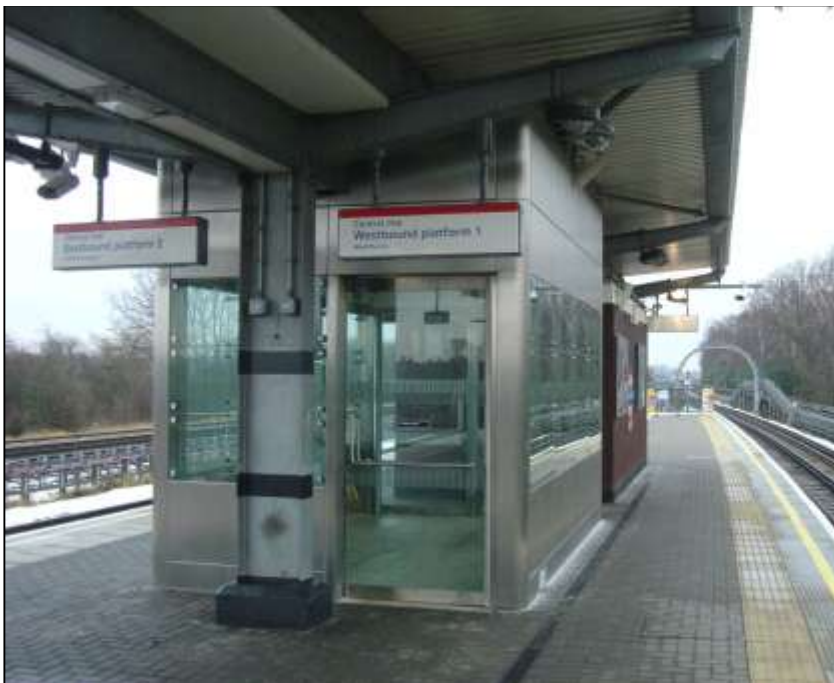
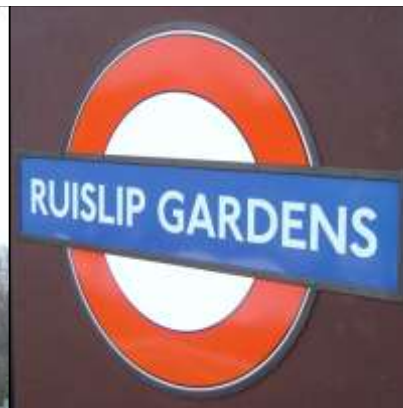
It appears that the incorrect font has been applied to the new roundels at Ruislip Gardens (*above*), and the waiting room (*left*) comprises an 'aluminium' shell rather than the usual glass. For many years the platform numbers here have been different from the normal

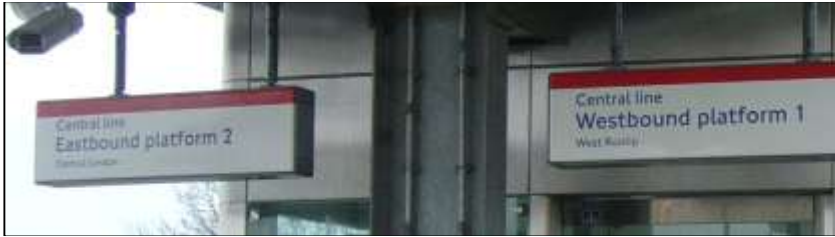
standard but resigning has meant that traditional numbering has been restored (left).

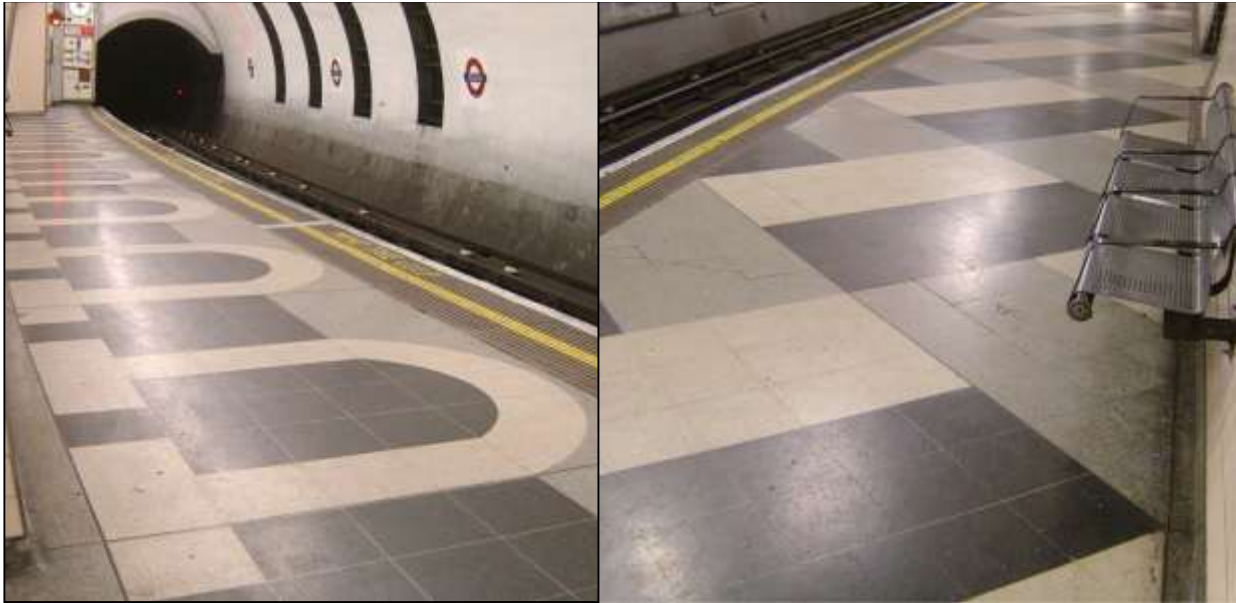
The Northern Line platforms are being finished in the same style as the Bakerloo and both seem to be running in parallel, progress wise. The distinctive platform flooring on both the Bakerloo (*below, left*), and Northern platforms (*below, right*) is being kept.

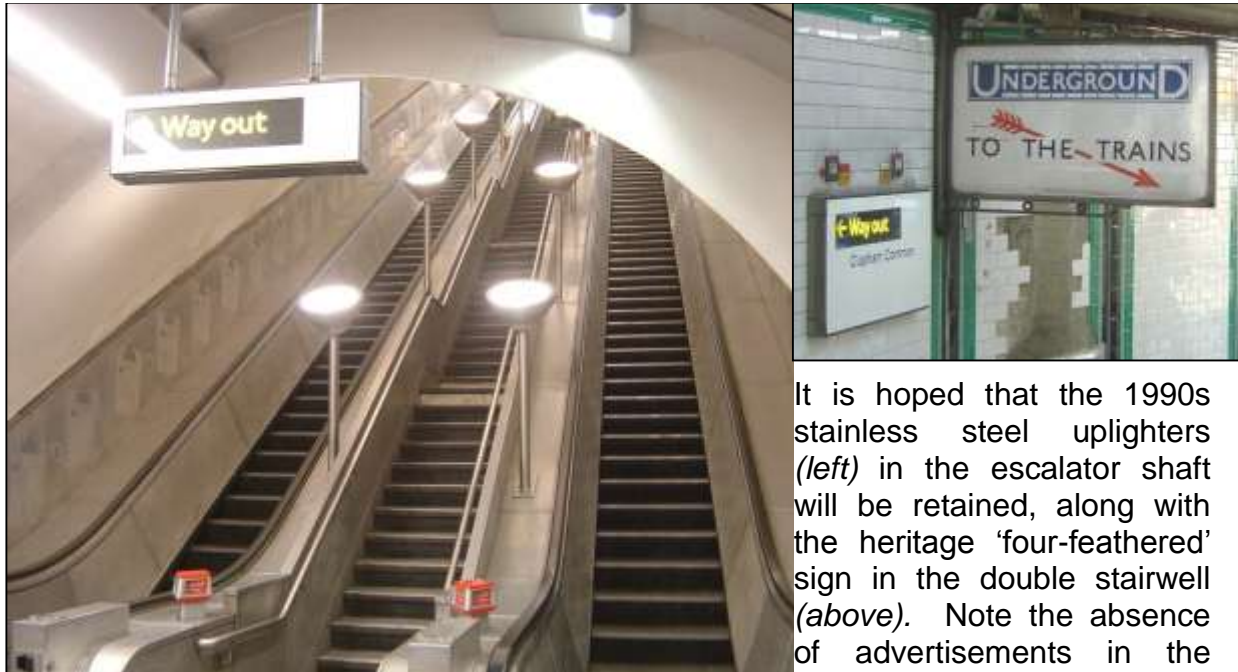
It is hoped that the 1990s stainless steel uprighters (*left*) in the escalator shaft will be retained, along with the heritage 'four-feathered' sign in the double stairwell (*above*). Note the absence of advertisements in the escalator shaft.

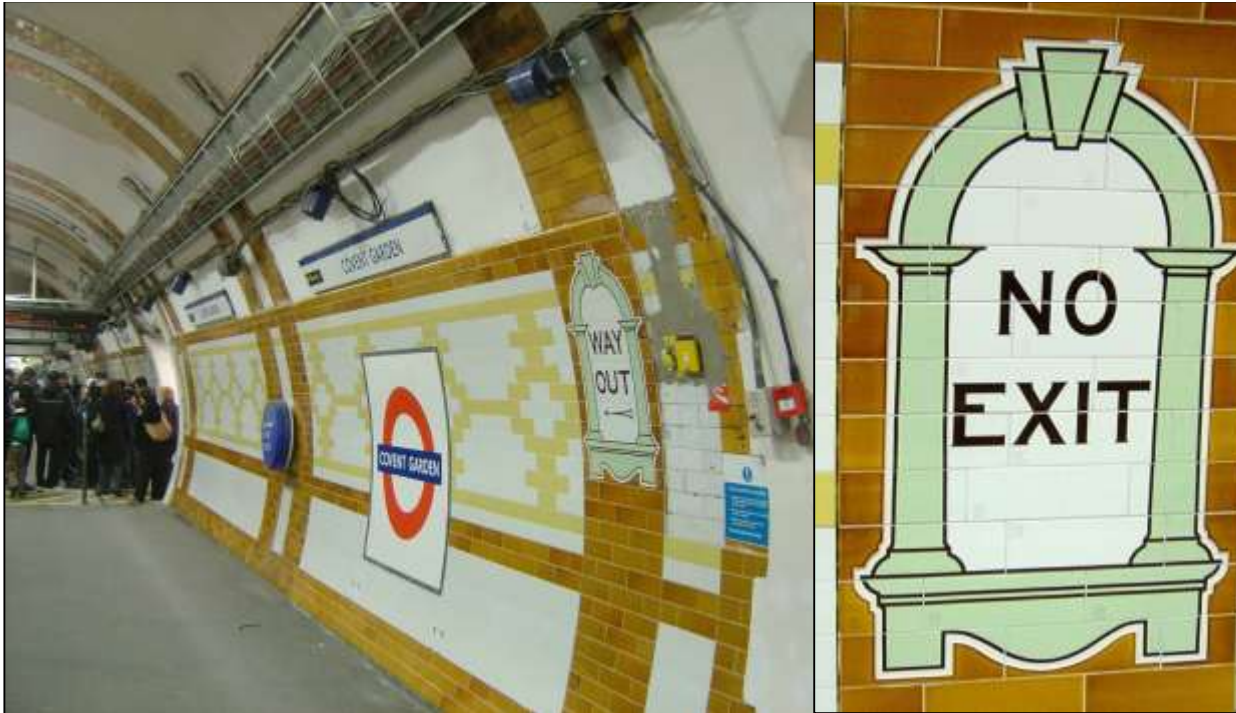
COVENT GARDEN – This station is also being retiled in heritage style, but again with the new tiles being applied over the old ones (*above, left*). Despite this, it is pleasing to note that the ‘Way Out’ and ‘No Exit’ tiles have been copied with most now in place (*above, right*). New lighting has been commissioned on both platforms. The troughing for the cables can also be seen and at present, the old ‘tin can’ PA speakers remain in use.

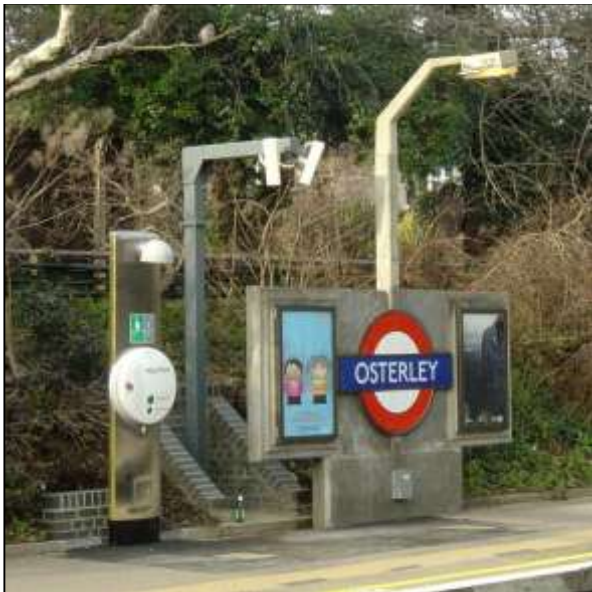
OSTERLEY – One of the pleasing aspects of the now completed refurbishment here is that the posts for CCTV and PA speakers have been set back in specially constructed brick recesses, seen here (*left*) on 16 February 2009. One of the new Help Points is seen to the left, which is illuminated, the lamp for which is above. The concrete lamp and sign stands are not, of course, original, having been replaced in the 1980s. The originals had more graceful curves, while the replacements, seen here, are more ‘angled’. The ticket hall has also been restored with heritage features, including the individual lettering above the various doors.

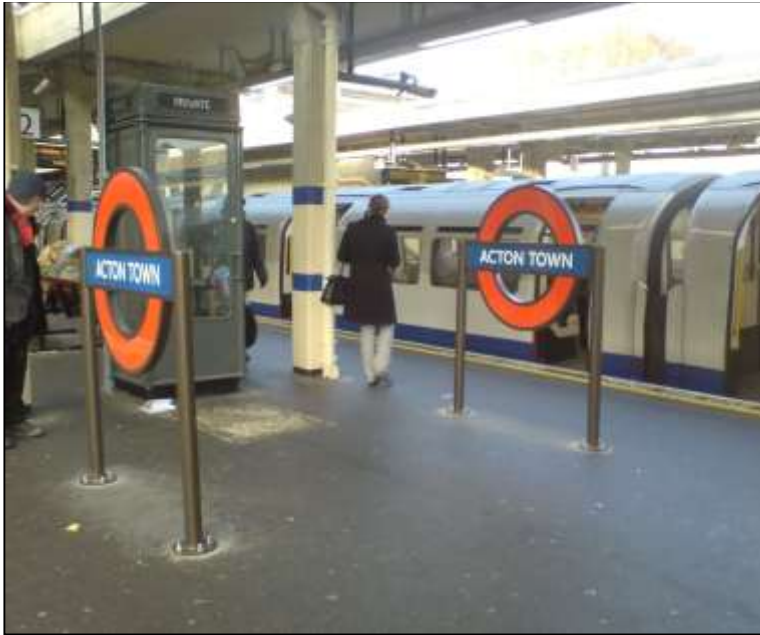
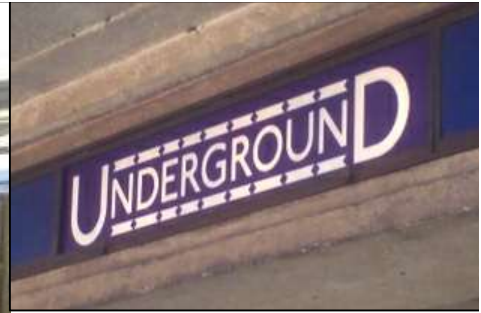
A nice touch at Acton Town are the 'fishtail' heritage Underground signs under the canopy (*above*), which look even better when illuminated at night. A traditional full-size roundel, normally found on platforms, has also been installed on the wall at the Bollo Lane entrance to the station. The free-standing roundels (*above left*) were remarkably only in place for a couple of weeks. Not only were they out of keeping on a 1930s heritage station but were probably unnecessary obstructions. By the end of January 2009, one had been removed and the other had been placed between seats (*left*) giving a sort of modern 'take' on the old wooden roundel seats at Hammersmith and High Street for example. One wonders if the displaced roundel will find its way into a similar position on the eastbound?

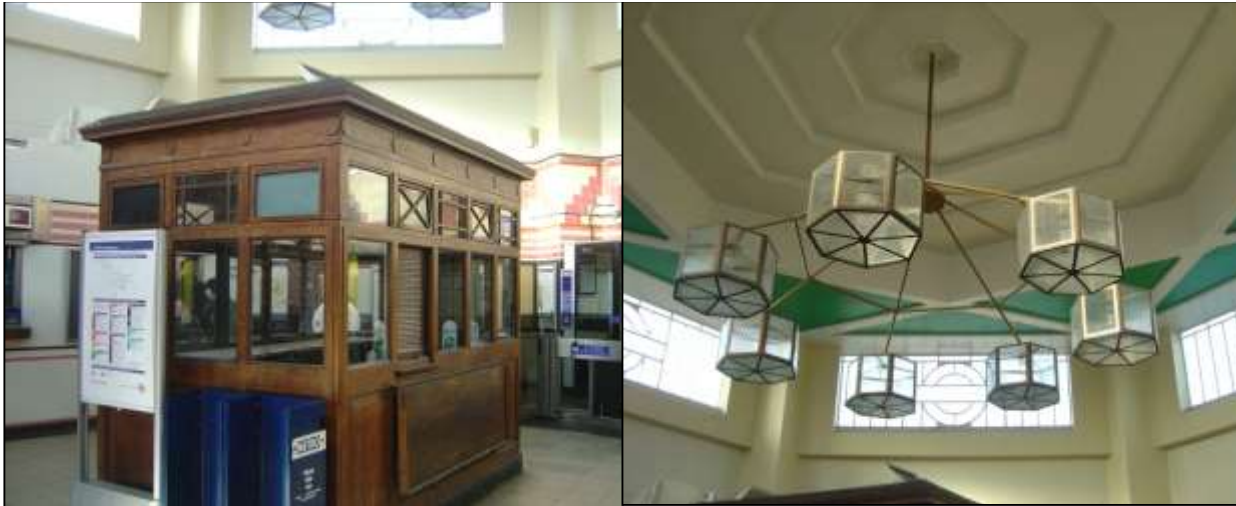
HOUNSLOW WEST – The platforms here remain virtually unchanged, save for a general tidy up, as they are only 34 years old and in good order. The heritage ticket hall, presumably having listed status, retains the wooden District Railway passimeter (*overleaf, top left*) and the seven-sided lamp shades (*overleaf, top right*), behind which can also be seen roundels in the glass.

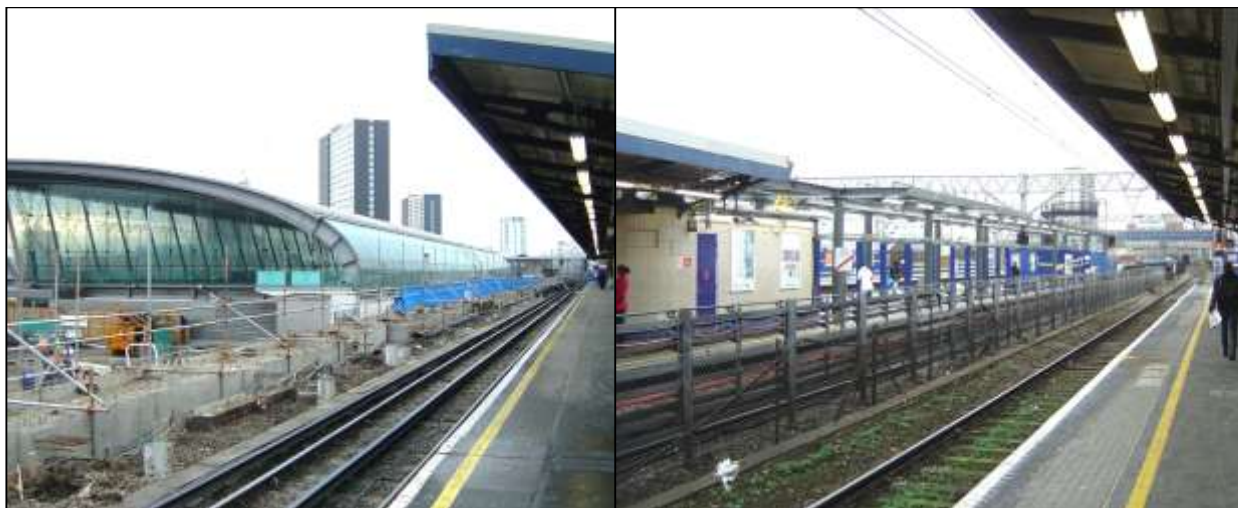
STRATFORD – The situation on 12 December 2008 is shown below with the site of the additional westbound platform taking shape (*below, left*) and the new canopies being installed over platforms 5 and 6 (*below, right*).

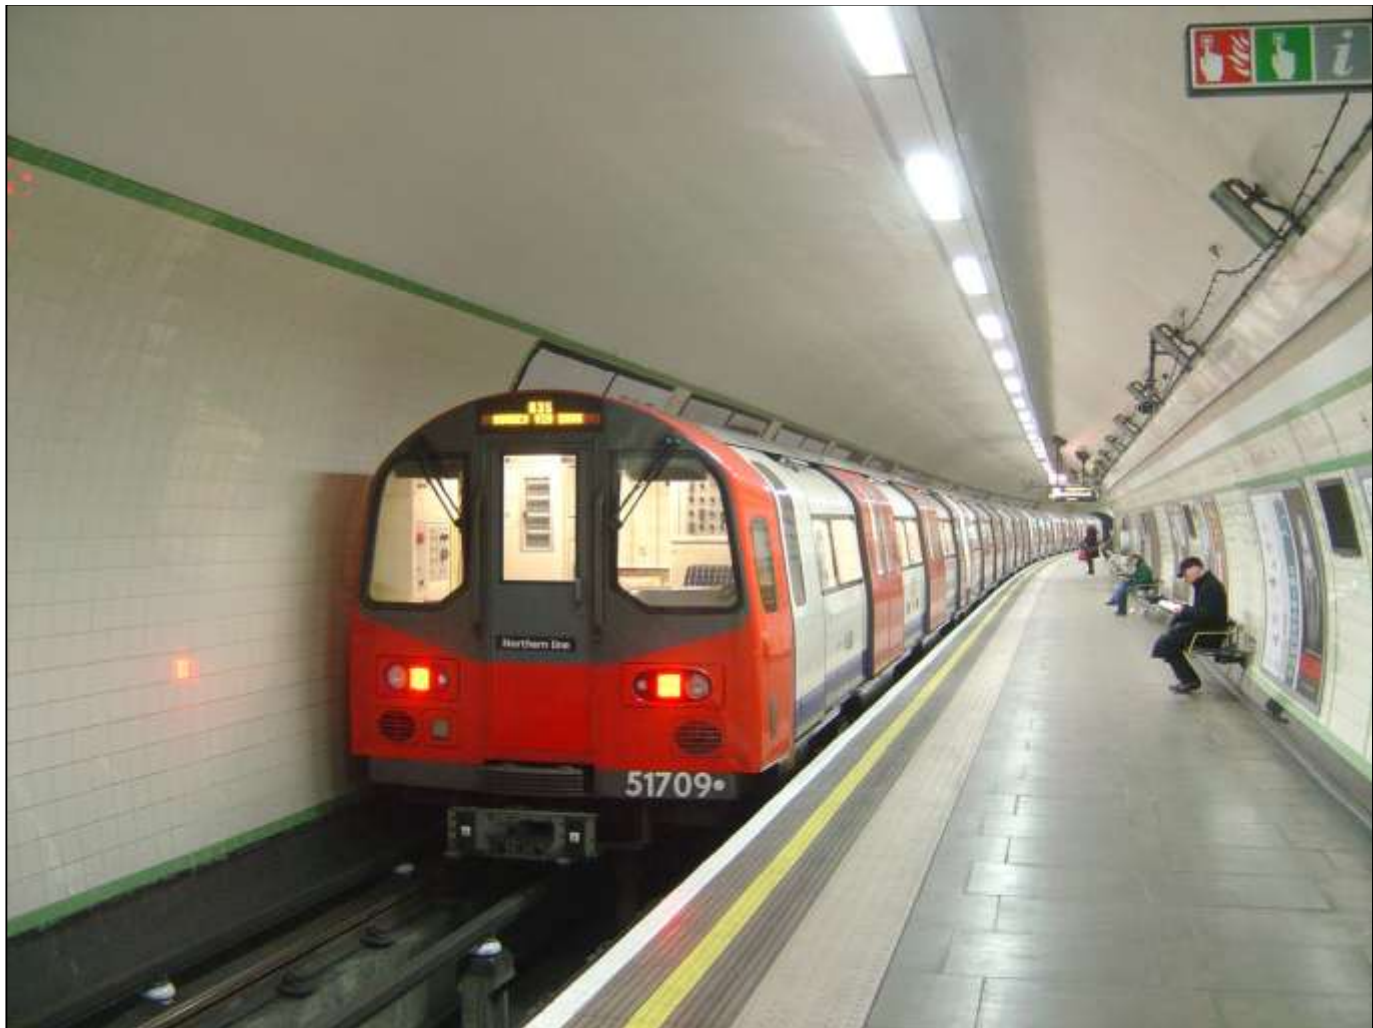
HIGHGATE – Although regarded as ‘completed’ in 2008, there are cables which continue to run along the platforms above frieze level, rather than having been enclosed, as seen here above, at the top right, on 16 February 2009.
