THE LONDON ELECTRIC TRAIN

8 – CAPACITY CRISIS

by Piers Connor

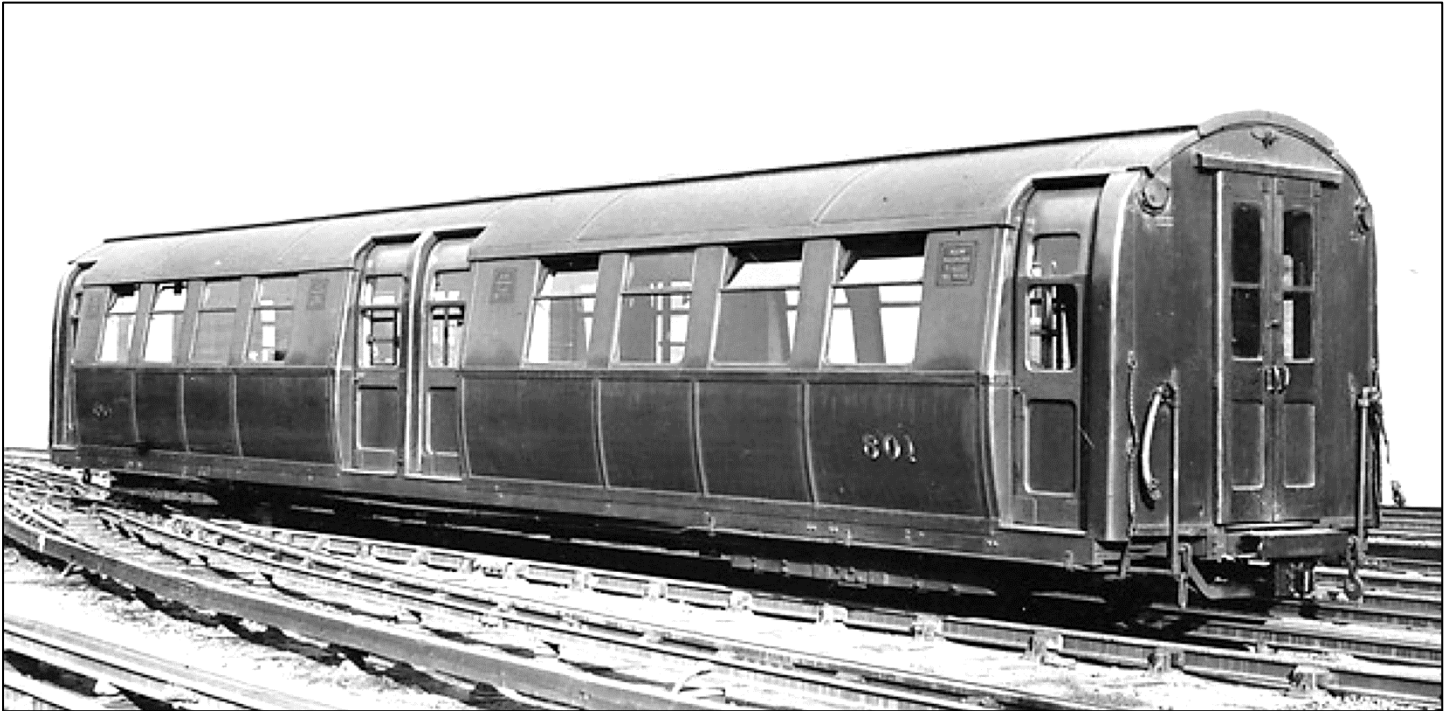
Figure 1: 1920 Cammell Laird Stock trailer car No. 801 as photographed in Lillie Bridge depot in February 1925, over four years after it was delivered. The curved bodyside shape was an attempt to make room for the “air engines”, as the door operating equipment was called, without reducing the seat and standing spaces too much. The central double door opening was strengthened by a substantial vertical pillar some 7 inches wide. The car end shows the sockets for the auxiliary and control jumpers on either side at roof level and, over the centre doorway, the socket for the emergency lighting jumper. These cars were not provided with heaters. Photo: LT Museum.

The new cars were designed with arched roof bodies, fully enclosed and equipped with a single door at each end and double doors in the centre of the cars, separated by a vertical pillar roughly 7 inches thick (Figure 1). The single doors had a 2-foot opening, while each leaf of the double doors allowed a 2ft 9in opening.

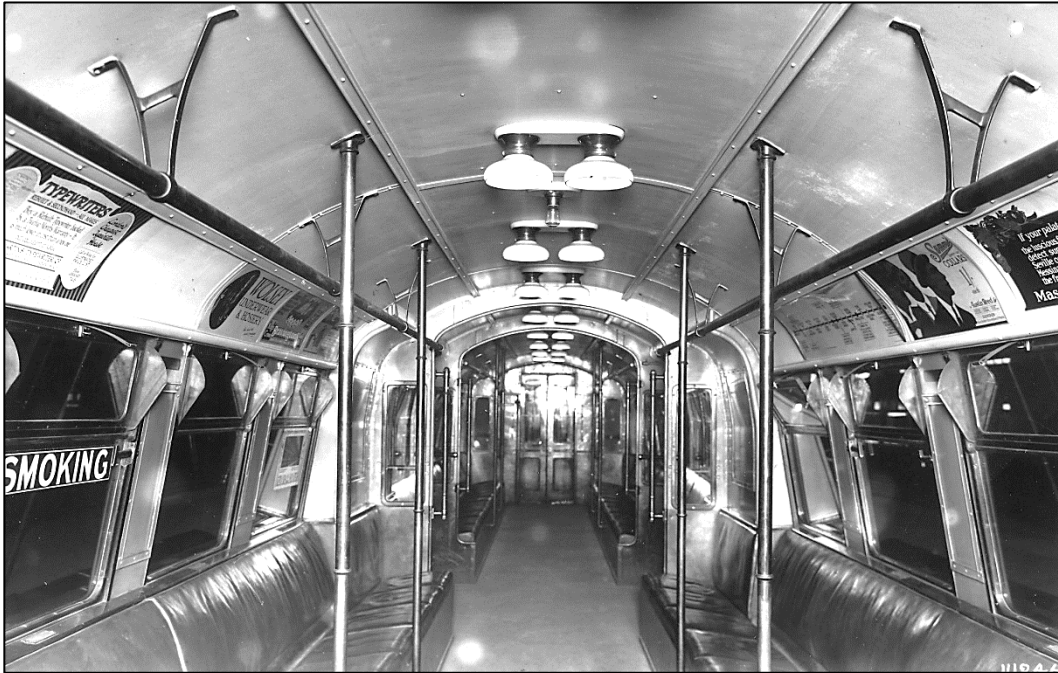
Figure 2: Interior of 1920 Cammell Laird stock car as built with plain leather longitudinal seating, vertical grab poles, horizontal handrails, plain cement flooring and twin, shaded lamps down the centre of the ceiling. The design was similar to the District Railway's F Stock of the same era. Both were later re-modelled with moquette seating and rearranged lighting.

The Cammell Laird car interiors were built with all-longitudinal seating for 44 persons. The idea was to maximise the standing space and thus increase train capacity. The cars were delivered with vertical hand rails in front of the seating benches but these were removed after a short time in service.

The whole interior was plain to the point of spartan and was designed simply to "pack 'em in". The seating was leather covered to make it easy to keep clean but leather can feel cold in winter and sticky in summer. The British public didn't like it and said so frequently, so much so that, in 1925, the Underground rebuilt the interior of at least one vehicle with moquette upholstered seating, a brighter paint scheme and some transverse seat pairs between the doorways. Money to do the whole batch was authorised in 1926 but it wasn't done until 1931, as we will see in a future article.
